# Access Compliance Report

## Public Rights-of-Way

### (Curb Ramps)

| ADA ID: 2AD48B200412 | Ramp Type: PerpDiag | Initial Pass/Fail: Fail | Overall Compliance: No |

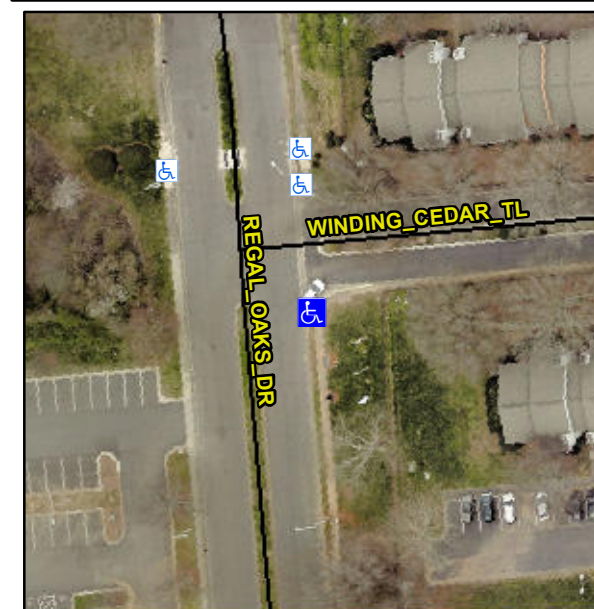
**Not Found, R304.2.2**

| Compliance | Description | Data | Compliance | Description | Data |
|---|---|---|---|---|---|
| N/A | Ramp Length (in) | 48.0 | No | Ramp Slope (%) | 12.0 |

**Remove & Replace Curb Ramp With Two New Directional Ramps or Equivalent.**
