# Access Compliance Report

## Public Rights-of-Way

### (Curb Ramps)

Intersection ID: 14066	Main Street: MARKLAND_DR	Cross Street: MAYFAIR_AV	Location: S
ADA ID: 2B1C542F84F3	Ramp Type: Perp	Initial Pass/Fail: Fail	Overall Compliance: No
			Severity Score: 21.25

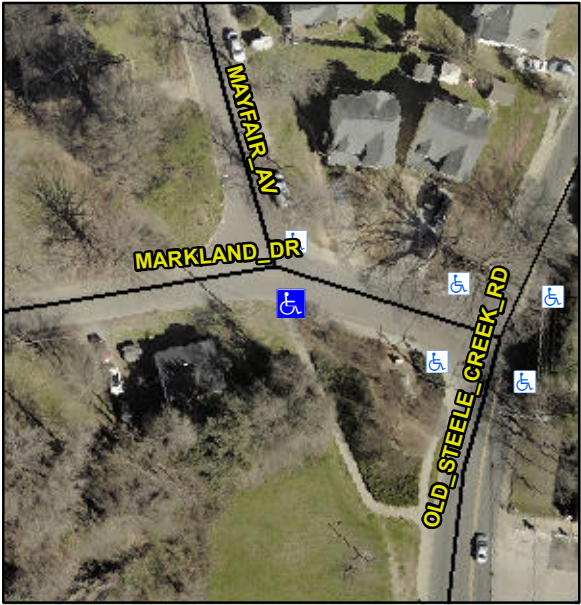
Possible Solutions:		<b>Compliance</b>	<b>Description</b>	<b>Data</b>
	Remove & Replace Entire Ramp.		N/A	Ramp Length (in)	60.0
			No	Ramp Width (in)	47.0
			N/A	Flare Type LT	N/A
			N/A	Flare Slope LT (%)	N/A
			N/A	Flare Traversable LT?	N/A
			N/A	Landing Length (in)	N/A
			N/A	Landing Width (in)	N/A
			N/A	Landing Slope (%)	N/A
			N/A	Landing X Slope (%)	N/A
<p>Surveyor Notes:</p> <p>N/A</p> <p>PROW/ADA:</p> <p>Not Found, R304.5.1, R304.2.2</p>			N/A	Flare Type RT	N/A
			N/A	Flare Slope RT (%)	N/A
			N/A	Flare Traversable RT?	N/A
			N/A	DWS Provided?	N/A
			N/A	DWS Contrast?	N/A
			N/A	DWS Length (in)	N/A
			N/A	DWS Full Width?	N/A
			N/A	DWS Offset (in)	N/A
			N/A	Shared Landing?	N/A
			N/A	Gutter Ponding?	N/A
			N/A	Gutter Lip Ht (in)	N/A
			N/A	Painted X Walk1?	No
				X Walk 1 Direction	To N
			N/A	X Walk 1 Width (in)	N/A

X Walk 1 Slope (%)	2.1
				X Walk 1 X Slope (%)	2.3
			N/A	Ramp inside XWalk1?	N/A
				Road Slope (%)	N/A
				Road X Slope (%)	N/A
			N/A	Any Obstructions?	N/A
				Obstruction Type	
Total Cost:		\$ 1850.00			
			N/A		N/A
			Yes	Surface Condition? (G/P)	Good
