Intersection ID: 9046	Main Street: BRADFORD_DR	Cross Street: HOOVER_ST	Location:	N
ADA ID: 2B338219C3A7	Ramp Type: BlendTrans2	Initial Pass/Fail: Fail	Overall Compliance: No	Severity Score: 21.25

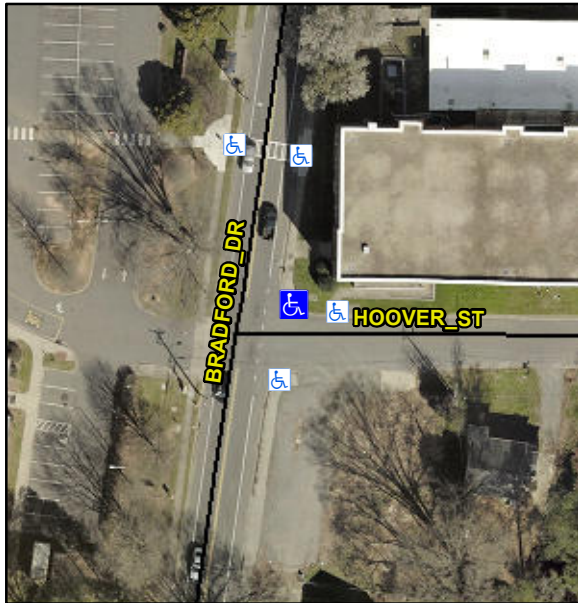
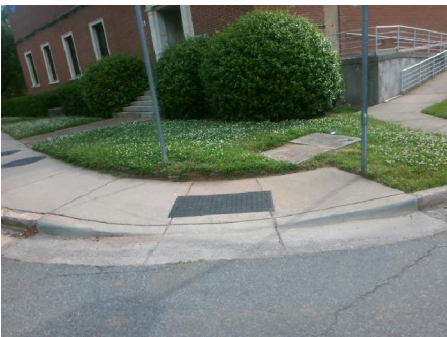
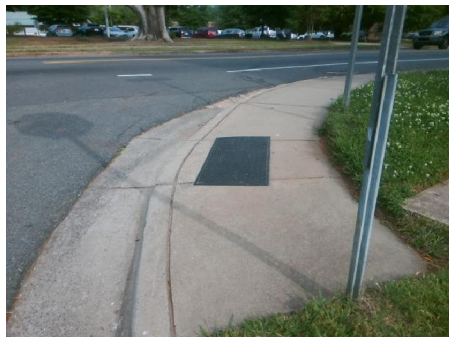
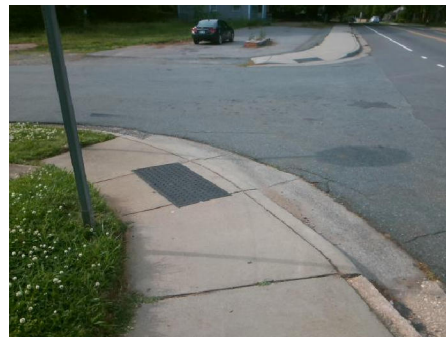
**NO RT SW**

**Not Found, R304.5.1, R304.5.3**

Compliance	Description	Data	Compliance	Description	Data
N/A	Ramp Length (in)	72.0	Yes	BlendTrans Slope (%)	3.1
No	Ramp Width (in)	36.0	No	BlendTrans XSlope (%)	5.1
N/A	Flare Type LT	N/A	N/A	Flare Type RT	N/A
N/A	Flare Slope LT (%)	N/A	N/A	Flare Slope RT (%)	N/A
N/A	Flare Traversable LT?	N/A	N/A	Flare Traversable RT?	N/A
N/A	Landing Length (in)	N/A	N/A	DWS Provided?	N/A
N/A	Landing Width (in)	N/A	N/A	DWS Contrast?	N/A
N/A	Landing Slope (%)	N/A	N/A	DWS Length (in)	N/A
N/A	Landing X Slope (%)	N/A	N/A	DWS Full Width?	N/A
N/A	Landing Curb? (Y/N)	N/A	N/A	DWS Offset (in)	N/A
N/A	Shared Landing?	N/A			
N/A	Gutter Ponding?	N/A	N/A	Gutter Slope (%)	N/A
N/A	Gutter Lip Ht (in)	N/A	N/A	Gutter X Slope (%)	N/A
N/A	Painted X Walk1?	No	N/A	Painted X Walk2?	N/A
	X Walk 1 Direction	To S		X Walk 2 Direction	N/A
	X Walk 1 Width (in)	N/A		X Walk 2 Width (in)	N/A
	X Walk 1 Slope (%)	0.2		X Walk 2 Slope (%)	N/A
	X Walk 1 X Slope (%)	6.5		X Walk 2 X Slope (%)	N/A

N/A	Ramp inside XWalk1?	N/A	N/A	Ramp inside XWalk2?	N/A
	Road Slope (%)	6.5		Clear Space?	N/A
	Road X Slope (%)	0.2	N/A	Clear Space to XWalk (in)	N/A
N/A	Any Obstructions?	N/A	N/A	Storm Grate/Utility Hazard?	N/A
	Obstruction Type			Storm Grate/Utility Type	
		N/A			N/A
			Yes	Surface Condition? (G/P)	Good
			No	Curb Slope (%)	16.2

**Remove & Replace Curb Ramp With Two New Directional Ramps or Equivalent.**
