# Access Compliance Report

## Public Rights-of-Way

| Intersection ID: 22536 | Main Street: PROVIDENCE_RD | Cross Street: SUMMERTREE_LN | Location: NW |
| ADA ID: 2B7057E73176 | Ramp Type: Perp | Initial Pass/Fail: Fail | Overall Compliance: No |

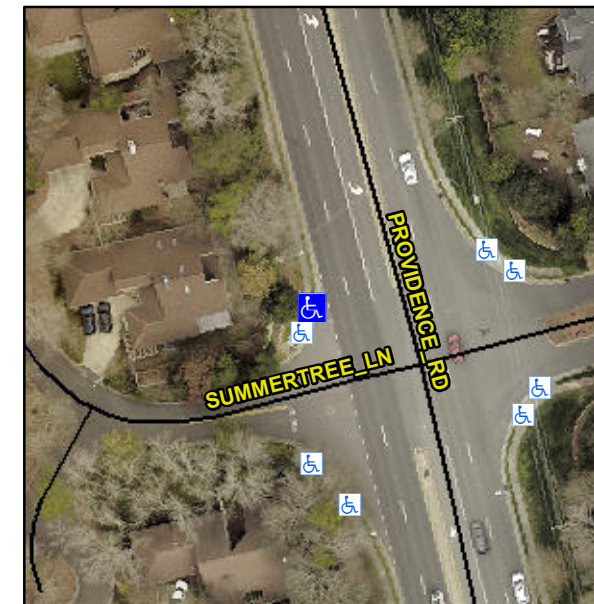
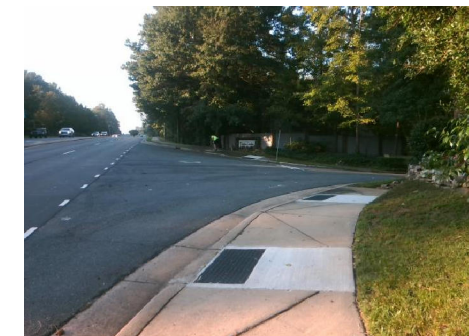
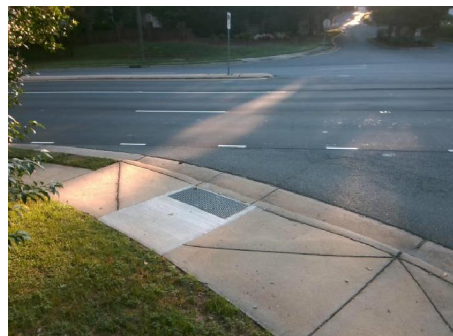
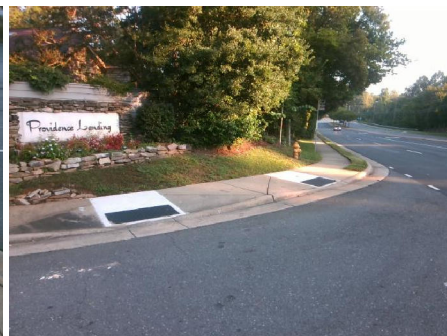
| Severity Score: 12.5 | | | |

**R304.2.2**

| Compliance | Description | Data | Compliance | Description | Data |
|---|---|---|---|---|---|
| N/A | Ramp Length (in) | 72.0 | No | Ramp Slope (%) | 10.2 |

**Remove & Replace Entire Ramp.**

**\$ 1850.00**
