Access Compliance Report Public Rights-of-Way (Curb Ramps)

Intersection ID: 2761 Main Street: BEAUVISTA_DR Cross Street: MAPLE_COVE_LN Location: SW

ADA ID: 2BC98E0B5BCB Ramp Type: PerpDiag Initial Pass/Fail: Fail Overall Compliance: No Severity Score: 33.75

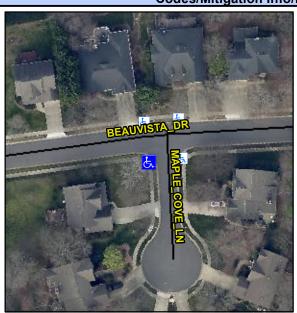
Not Found, R304.5.1, R304.5.3

Field Measurements/Component Compliance						
	Compliance Description		Data	Comp	oliance Description	Data
	N/A	Ramp Length (in)	42.0	Yes	Ramp Slope (%)	5.0
	No	Ramp Width (in)	39.0	No	Ramp XSlope (%)	9.6
	N/A	Flare Type LT	N/A	N/A	Flare Type RT	N/A
	N/A	Flare Slope LT (%)	N/A	N/A	Flare Slope RT (%)	N/A
	N/A	Flare Traversable LT?	N/A	N/A	Flare Traversable RT?	N/A
	N/A	Landing Length (in)	N/A	N/A	DWS Provided?	N/A
	N/A	Landing Width (in)	N/A	N/A	DWS Contrast?	N/A
	N/A	Landing Slope (%)	N/A	N/A	DWS Length (in)	N/A
	N/A	Landing X Slope (%)	N/A	N/A	DWS Full Width?	N/A
	N/A	Landing Curb? (Y/N)	N/A	N/A	DWS Offset (in)	N/A
	N/A	Shared Landing?	N/A			
	N/A	Gutter Ponding?	N/A	N/A	Gutter Slope (%)	N/A
	N/A	Gutter Lip Ht (in)	N/A	N/A	Gutter X Slope (%)	N/A
	N/A	Painted X Walk1?	No	N/A	Painted X Walk2?	No
		X Walk 1 Direction	To E		X Walk 2 Direction	To N
	N/A	X Walk 1 Width (in)	N/A	N/A	X Walk 2 Width (in)	N/A
		X Walk 1 Slope (%)	8.0		X Walk 2 Slope (%)	1.4

X Walk 1 X Slope (%)	5.1		X Walk 2 X Slope (%)	7.0
	N/A	Ramp inside XWalk1?	N/A	N/A	Ramp inside XWalk2?	N/A
		Road Slope (%)	6.9	N/A	Clear Space?	N/A
		Road X Slope (%)	5.9	N/A	Clear Space to XWalk (in)	N/A
	N/A	Any Obstructions?	N/A	N/A	Storm Grate/Utility Hazard?	N/A
		Obstruction Type			Storm Grate/Utility Type	
			N/A			N/A
				Yes	Surface Condition? (G/P)	Good
an a		N 100 1 100

Remove & Replace Curb Ramp With Two New Directional Ramps or Equivalent.
