Access Compliance Report

Public Rights-of-Way (Curb Ramps)

Intersection ID: 11413		Main Street: EAST_FORD_RD		Cross Street: SHAMROCK_DR		Location: SW			
ADA ID: 2C308E3670C8		Ramp Type: Directional1		Initial Pass/Fail: Fail		Overall Compliance: No		Severity Score: 12.5	
Codes/Mitigation Info/Possible Solution				Field Measurements/Component Compliance					
<div>

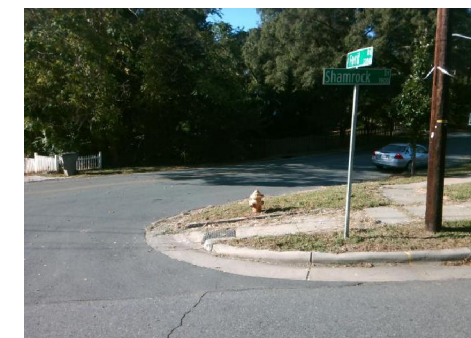
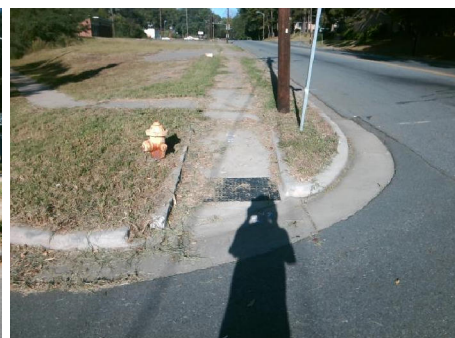
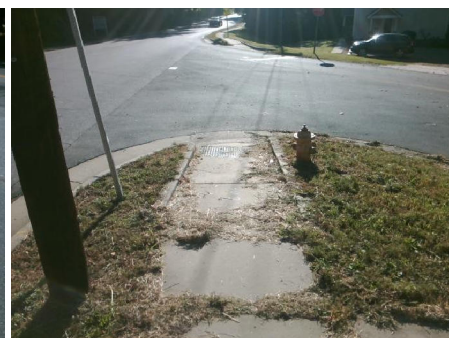
</div> <div>Possible Solutions:</div> <div>Remove & Replace Entire Ramp.</div> <div>Surveyor Notes:</div> <div>N/A</div> <div>PROW/ADA:</div> <div>R304.2.2</div> <div>Street 1 Name</div> <div>EAST FORD RD</div> <div>Stop Condition-Street 1</div> <div>StopSign</div> <div>Street 2 Name</div> <div>N/A</div> <div>Stop Condition-Street 2</div> <div>N/A</div> <div>Total Cost:</div> <div>\$</div> <div>1600.00</div>				Compliance	Description	Data	Compliance	Description	Data
				N/A	Ramp Length (in)	120.0	N/A	Grade Break?	N/A
				Yes	Ramp Width (in)	54.0	N/A	Grade Break Slope (%)	0.0
				No	Ramp Slope (%)	10.6	N/A	Grade Break XSlope (%)	0.0

Yes	Ramp XSlope (%)	0.6			
				N/A	Flare Type LT	N/A	N/A	Flare Type RT	N/A
				N/A	Flare Slope LT (%)	N/A	N/A	Flare Slope RT (%)	0.0
				N/A	Flare Traversable LT?	N/A	N/A	Flare Traversable RT?	N/A
				N/A	Landing Length (in)	0.0	N/A	DWS Provided?	N/A
				N/A	Landing Width (in)	0.0	N/A	DWS Contrast?	N/A
				N/A	Landing Slope (%)	0.0	N/A	DWS Length (in)	N/A
				N/A	Landing X Slope (%)	0.0	N/A	DWS Full Width?	N/A
				N/A	Landing Curb? (Y/N)	N/A	N/A	DWS Offset LT (in)	N/A
				N/A	Shared Landing?	N/A	N/A	DWS Offset RT (in)	N/A
				N/A	Gutter Ponding?	0.0	N/A	Gutter Slope (%)	N/A
				N/A	Gutter Lip Ht (in)	0.0	N/A	Gutter X Slope (%)	N/A
				N/A	Painted X Walk1?	No		Road Slope (%)	0.8
					X Walk 1 Direction	To SE		Road X Slope (%)	4.9
					X Walk 1 Width (in)	N/A		Clear Space?	N/A
					X Walk 1 Slope (%)	0.8	N/A	Clear Space to XWalk (in)	N/A
					X Walk 1 X Slope (%)	4.9	N/A	Storm Grate/Utility Hazard?	N/A

N/A	Ramp inside XWalk1?	N/A		Storm Grate/Utility Type	
				N/A	Any Obstructions?	N/A			N/A
					Obstruction Type		Yes	Surface Condition? (G/P)	Good
							N/A	Curb Slope (%)	9.0
