Access Compliance Report

Public Rights-of-Way

(Curb Ramps)

Intersection ID: 45172	Main Street: ELDON_DR	Cross Street: LINDEN_TREE_LN	Location: NE
ADA ID: 2C918D1C842E	Ramp Type: PerpDiag	Initial Pass/Fail: Fail	Overall Compliance: No
Severity Score: 12.5			
Codes/Mitigation Info/Possible Solution		Field Measurements/Component Compliance

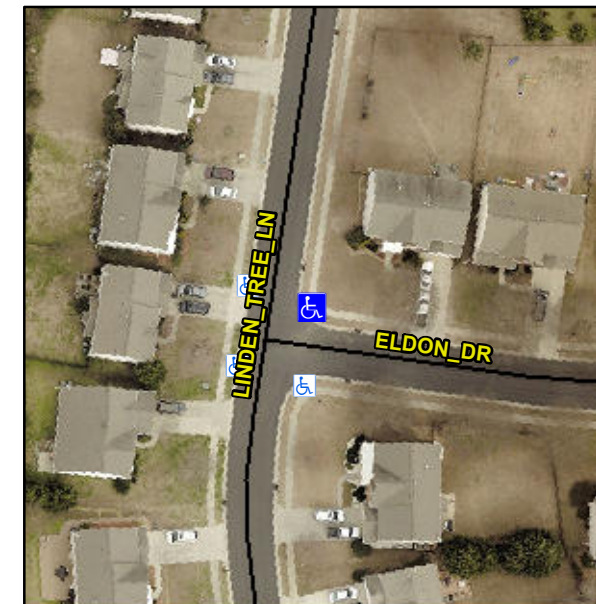
PROW/ADA:

Not Found, R304.2.2

Compliance	Description	Data	Compliance	Description	Data
N/A	Ramp Length (in)	36.0	No	Ramp Slope (%)	8.8
Yes	Ramp Width (in)	56.5	Yes	Ramp XSlope (%)	0.6
N/A	Flare Type LT	N/A	N/A	Flare Type RT	N/A
N/A	Flare Slope LT (%)	N/A	N/A	Flare Slope RT (%)	N/A
N/A	Flare Traversable LT?	N/A	N/A	Flare Traversable RT?	N/A
N/A	Landing Length (in)	N/A	N/A	DWS Provided?	N/A
N/A	Landing Width (in)	N/A	N/A	DWS Contrast?	N/A
N/A	Landing Slope (%)	N/A	N/A	DWS Length (in)	N/A
N/A	Landing X Slope (%)	N/A	N/A	DWS Full Width?	N/A
N/A	Landing Curb? (Y/N)	N/A	N/A	DWS Offset (in)	N/A
N/A	Shared Landing?	N/A			
N/A	Gutter Ponding?	N/A	N/A	Gutter Slope (%)	N/A
N/A	Gutter Lip Ht (in)	N/A	N/A	Gutter X Slope (%)	N/A
N/A	Painted X Walk1?	No	N/A	Painted X Walk2?	No
	X Walk 1 Direction	To NW		X Walk 2 Direction	To SW
N/A	X Walk 1 Width (in)	N/A	N/A	X Walk 2 Width (in)	N/A
	X Walk 1 Slope (%)	0.4		X Walk 2 Slope (%)	0.4
	X Walk 1 X Slope (%)	2.6		X Walk 2 X Slope (%)	0.4

Possible Solutions:

Remove & Replace Curb Ramp With Two New Directional Ramps or Equivalent.

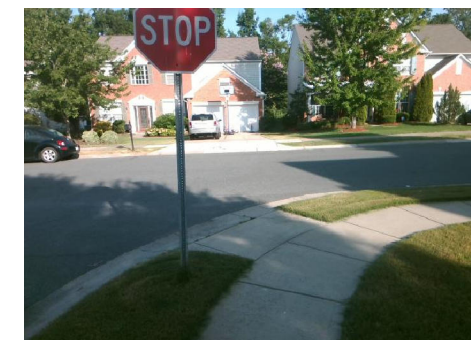
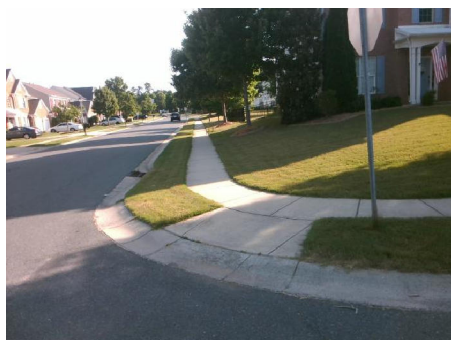
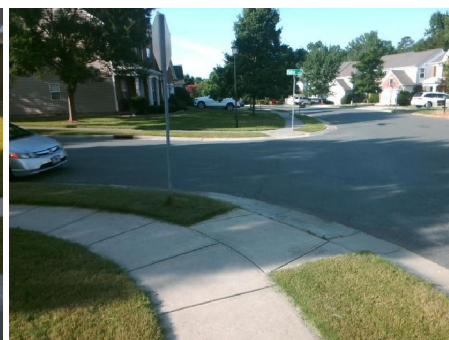
N/A	Ramp inside XWalk1?	N/A	N/A	Ramp inside XWalk2?	N/A
	Road Slope (%)	1.3	N/A	Clear Space?	N/A
	Road X Slope (%)	1.0	N/A	Clear Space to XWalk (in)	N/A
N/A	Any Obstructions?	N/A	N/A	Storm Grate/Utility Hazard?	N/A
	Obstruction Type			Storm Grate/Utility Type	
		N/A			N/A
			Yes	Surface Condition? (G/P)	Good
