Access Compliance Report

Public Rights-of-Way

(Curb Ramps)

Intersection ID: 8118	Main Street: DR_WEBBER_AV	Cross Street: CUSTER_ST	Location: SE
ADA ID: 2CABCB6B29F3	Ramp Type: Perp	Initial Pass/Fail: Fail	Overall Compliance: No
		Severity Score: 12.5

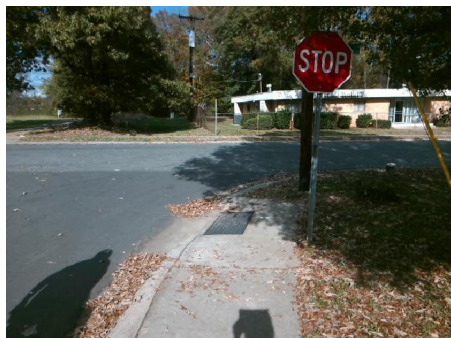
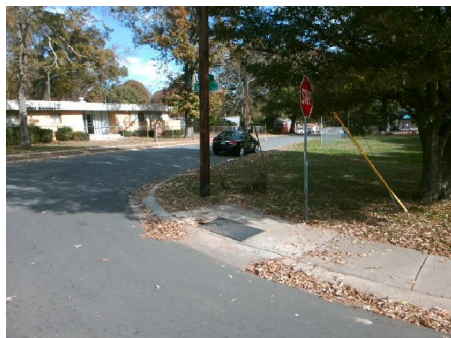
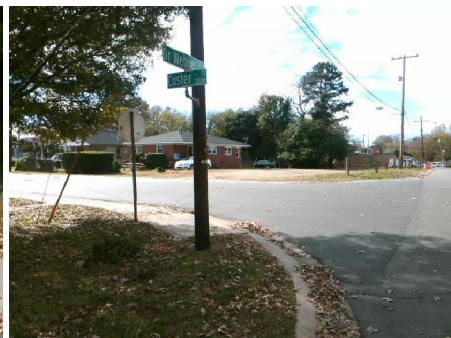
Surveyor Notes:		No	Ramp Slope (%)	8.5
	N/A		Yes	Ramp XSlope (%)	1.4

Possible Solutions:		Compliance	Description	Data
	Remove & Replace Entire Ramp.		Compliance	Description	Data
