# Access Compliance Report

## Public Rights-of-Way

| Intersection ID: 13086 | Main Street: CENTRAL_AV | Cross Street: CLEMENT_AV | Location: NE |
| ADA ID: 2CD5B61209A1 | Ramp Type: Perp | Initial Pass/Fail: Fail | Overall Compliance: No |

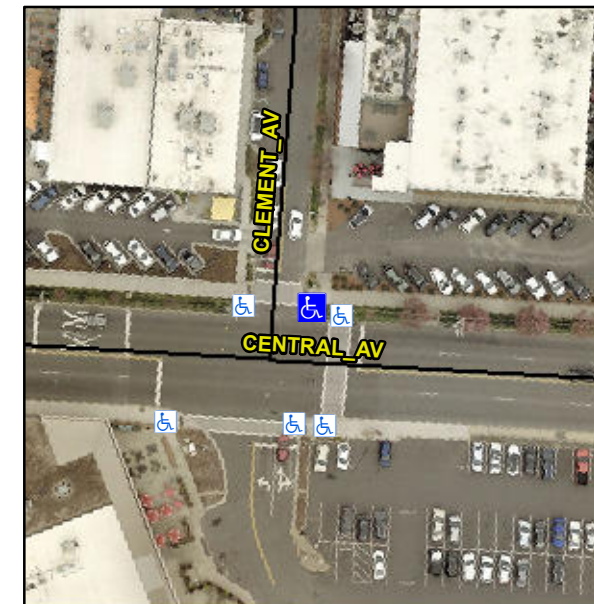
| Compliance | Description | Data | Compliance | Description | Data |
|---|---|---|---|---|---|
| N/A | Ramp Length (in) | 99.0 | No | Ramp Slope (%) | 9.9 |

**Remove & Replace Entire Ramp.**

**R304.2.2**

**\$ 1850.00**
