# Access Compliance Report

## Public Rights-of-Way

### (Curb Ramps)

Intersection ID: 14078	Main Street: EAST_BV	Cross Street: SOUTH_BV	Location: NE
ADA ID: 2CD84CCA6886	Ramp Type: BlendTrans2	Initial Pass/Fail: Fail	Overall Compliance: No
		Severity Score: 10

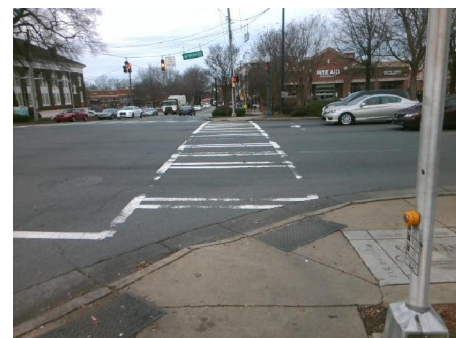
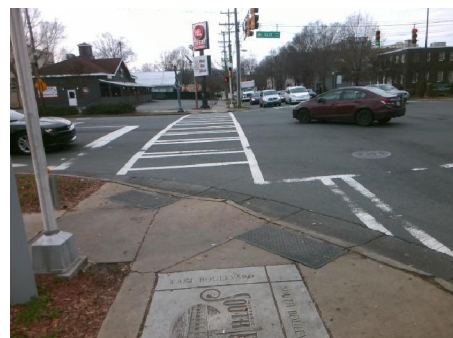
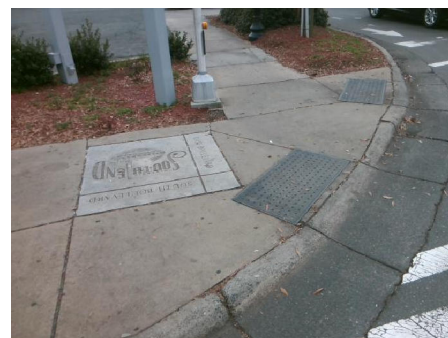
**Not Found, R304.5.1, R304.5.3**

Compliance	Description	Data	Compliance	Description	Data
N/A	Ramp Length (in)	29.0	Yes	BlendTrans Slope (%)	3.5
No	Ramp Width (in)	37.0	No	BlendTrans XSlope (%)	2.3
N/A	Flare Type LT	N/A	N/A	Flare Type RT	N/A
N/A	Flare Slope LT (%)	N/A	N/A	Flare Slope RT (%)	N/A
N/A	Flare Traversable LT?	N/A	N/A	Flare Traversable RT?	N/A
N/A	Landing Length (in)	N/A	N/A	DWS Provided?	N/A
N/A	Landing Width (in)	N/A	N/A	DWS Contrast?	N/A
N/A	Landing Slope (%)	N/A	N/A	DWS Length (in)	N/A
N/A	Landing X Slope (%)	N/A	N/A	DWS Full Width?	N/A
N/A	Landing Curb? (Y/N)	N/A	N/A	DWS Offset (in)	N/A
N/A	Shared Landing?	N/A			
N/A	Gutter Ponding?	N/A	N/A	Gutter Slope (%)	N/A
N/A	Gutter Lip Ht (in)	N/A	N/A	Gutter X Slope (%)	N/A
N/A	Painted X Walk1?	Yes	N/A	Painted X Walk2?	N/A
	X Walk 1 Direction	To NW		X Walk 2 Direction	N/A
	X Walk 1 Width (in)	120.0		X Walk 2 Width (in)	N/A
	X Walk 1 Slope (%)	2.0		X Walk 2 Slope (%)	N/A
	X Walk 1 X Slope (%)	1.2		X Walk 2 X Slope (%)	N/A

N/A	Ramp inside XWalk1?	Yes	N/A	Ramp inside XWalk2?	N/A
	Road Slope (%)	1.2		Clear Space?	N/A
	Road X Slope (%)	2.0	N/A	Clear Space to XWalk (in)	N/A
N/A	Any Obstructions?	N/A	N/A	Storm Grate/Utility Hazard?	N/A
	Obstruction Type			Storm Grate/Utility Type	
		N/A			N/A
			Yes	Surface Condition? (G/P)	Good
			No	Curb Slope (%)	14.1

**Remove & Replace Curb Ramp With Two New Directional Ramps or Equivalent.**
