Access Compliance Report

Public Rights-of-Way

(Curb Ramps)

Intersection ID: 29368	Main Street: LUNDY_LN	Cross Street: MOSSY_OAK_LN	Location: S
ADA ID: 2D43971C875E	Ramp Type: Perp	Initial Pass/Fail: Fail	Overall Compliance: No
Severity Score: 10			
Codes/Mitigation Info/Possible Solution		Field Measurements/Component Compliance

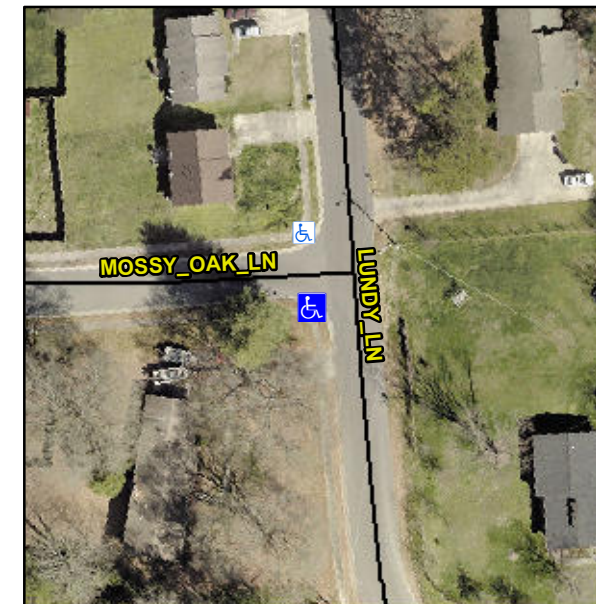
R304.5.1, R304.5.3

Compliance	Description	Data	Compliance	Description	Data
N/A	Ramp Length (in)	48.0	Yes	Ramp Slope (%)	8.0
No	Ramp Width (in)	44.0	No	Ramp XSlope (%)	3.3
N/A	Flare Type LT	N/A	N/A	Flare Type RT	N/A
N/A	Flare Slope LT (%)	N/A	N/A	Flare Slope RT (%)	N/A
N/A	Flare Traversable LT?	N/A	N/A	Flare Traversable RT?	N/A
N/A	Landing Length (in)	N/A	N/A	DWS Provided?	N/A
N/A	Landing Width (in)	N/A	N/A	DWS Contrast?	N/A
N/A	Landing Slope (%)	N/A	N/A	DWS Length (in)	N/A
N/A	Landing X Slope (%)	N/A	N/A	DWS Full Width?	N/A
N/A	Landing Curb? (Y/N)	N/A	N/A	DWS Offset (in)	N/A
N/A	Shared Landing?	N/A			
N/A	Gutter Ponding?	N/A	N/A	Gutter Slope (%)	N/A
N/A	Gutter Lip Ht (in)	N/A	N/A	Gutter X Slope (%)	N/A
N/A	Painted X Walk1?	No	N/A	Painted X Walk2?	N/A
	X Walk 1 Direction	To N		X Walk 2 Direction	N/A
N/A	X Walk 1 Width (in)	N/A	N/A	X Walk 2 Width (in)	N/A
	X Walk 1 Slope (%)	2.6		X Walk 2 Slope (%)	N/A
	X Walk 1 X Slope (%)	3.0		X Walk 2 X Slope (%)	N/A

Remove & Replace Entire Ramp.

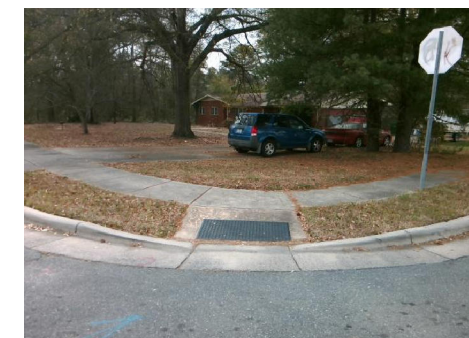
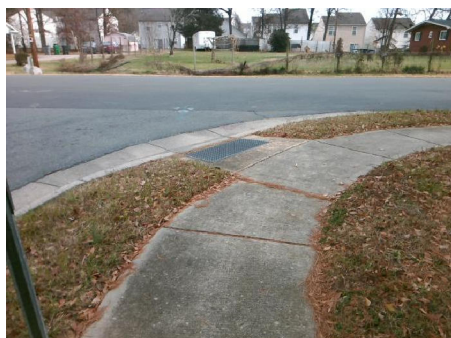
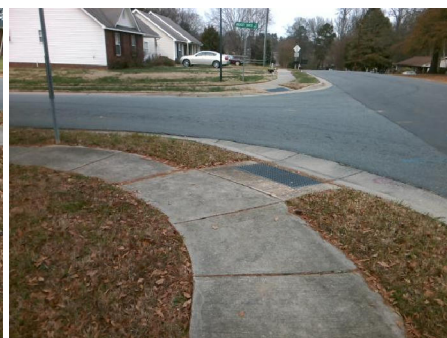
N/A	Ramp inside XWalk1?	N/A	N/A	Ramp inside XWalk2?	N/A
	Road Slope (%)	N/A	N/A	Clear Space?	N/A
	Road X Slope (%)	N/A	N/A	Clear Space to XWalk (in)	N/A
N/A	Any Obstructions?	N/A	N/A	Storm Grate/Utility Hazard?	N/A
	Obstruction Type			Storm Grate/Utility Type	
		N/A			N/A
			Yes	Surface Condition? (G/P)	Good
