# Access Compliance Report

## Public Rights-of-Way

### (Curb Ramps)

Intersection ID: 50607	Main Street: DENBUR_DR	Cross Street: STREAM_ORCHID_LN	Location: NE
ADA ID: 2E35C885E789	Ramp Type: Perp	Initial Pass/Fail: Fail	Overall Compliance: No
Severity Score: 8.75			
Codes/Mitigation Info/Possible Solution		Field Measurements/Component Compliance

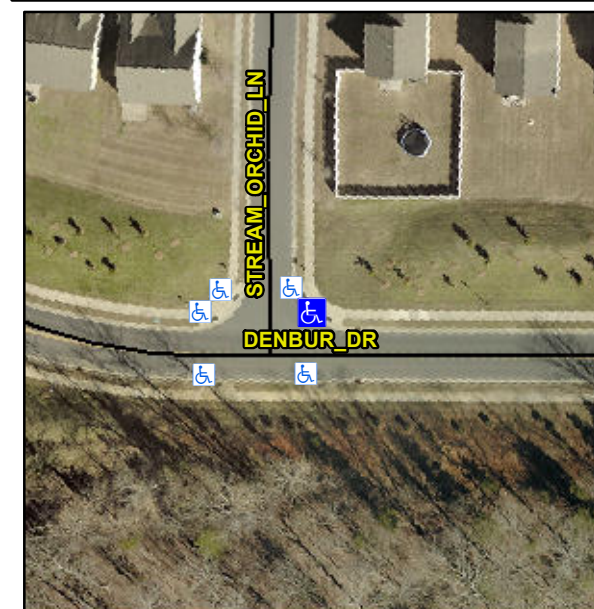
**Not Found, R304.5.1**

Compliance	Description	Data	Compliance	Description	Data
N/A	Ramp Length (in)	47.5	Yes	Ramp Slope (%)	7.6
No	Ramp Width (in)	47.5	Yes	Ramp XSlope (%)	1.1
N/A	Flare Type LT	N/A	N/A	Flare Type RT	N/A
N/A	Flare Slope LT (%)	N/A	N/A	Flare Slope RT (%)	N/A
N/A	Flare Traversable LT?	N/A	N/A	Flare Traversable RT?	N/A
N/A	Landing Length (in)	N/A	N/A	DWS Provided?	N/A
N/A	Landing Width (in)	N/A	N/A	DWS Contrast?	N/A
N/A	Landing Slope (%)	N/A	N/A	DWS Length (in)	N/A
N/A	Landing X Slope (%)	N/A	N/A	DWS Full Width?	N/A
N/A	Landing Curb? (Y/N)	N/A	N/A	DWS Offset (in)	N/A
N/A	Shared Landing?	N/A			
N/A	Gutter Ponding?	N/A	N/A	Gutter Slope (%)	N/A
N/A	Gutter Lip Ht (in)	N/A	N/A	Gutter X Slope (%)	N/A
N/A	Painted X Walk1?	No	N/A	Painted X Walk2?	N/A
	X Walk 1 Direction	To S		X Walk 2 Direction	N/A
N/A	X Walk 1 Width (in)	N/A	N/A	X Walk 2 Width (in)	N/A
	X Walk 1 Slope (%)	0.5		X Walk 2 Slope (%)	N/A
	X Walk 1 X Slope (%)	2.6		X Walk 2 X Slope (%)	N/A

**Remove & Replace Entire Ramp.**
