Access Compliance Report

Public Rights-of-Way

(Curb Ramps)

Intersection ID: N/A	Main Street: INVERNESS_BAY_RD	Cross Street: ELGIN_MOOR_RD	Location: SW
ADA ID: 2EF3F414D5D1	Ramp Type: Perp	Initial Pass/Fail: Fail	Overall Compliance: No
		Severity Score: 8.75

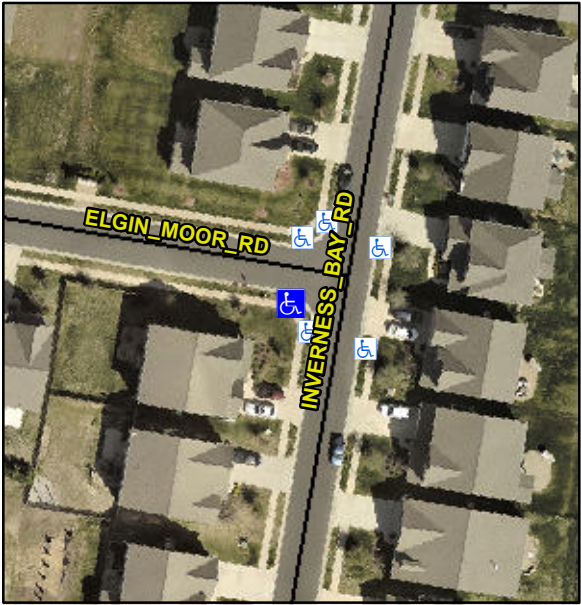
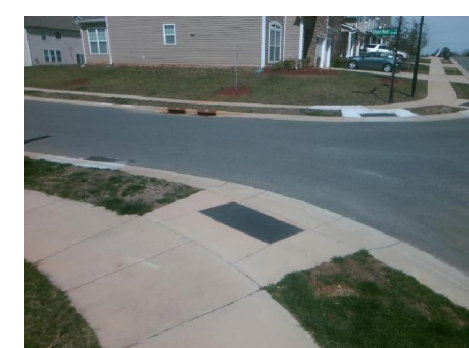
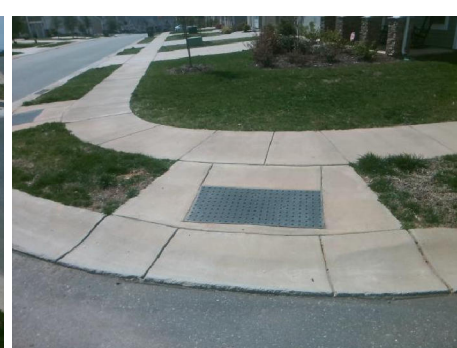
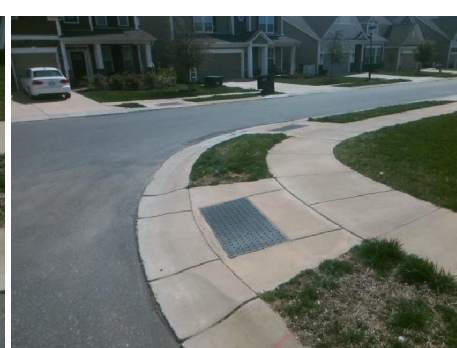
Possible Solutions:		Compliance	Description	Data
	Remove & Replace Entire Ramp.		N/A	Ramp Length (in)	49.0
			No	Ramp Width (in)	46.5
			N/A	Flare Type LT	N/A
			N/A	Flare Slope LT (%)	N/A
			N/A	Flare Traversable LT?	N/A
			N/A	Landing Length (in)	N/A
			N/A	Landing Width (in)	N/A
			N/A	Landing Slope (%)	N/A
			N/A	Landing X Slope (%)	N/A
<p>Surveyor Notes:</p> <p>N/A</p> <p>PROW/ADA:</p> <p>R304.5.1</p>			N/A	Flare Type RT	N/A
			N/A	Flare Slope RT (%)	N/A
			N/A	Flare Traversable RT?	N/A
			N/A	DWS Provided?	N/A
			N/A	DWS Contrast?	N/A
			N/A	DWS Length (in)	N/A
			N/A	DWS Full Width?	N/A
			N/A	DWS Offset (in)	N/A
			N/A	Gutter Ponding?	N/A
			N/A	Gutter Lip Ht (in)	1.0
			N/A	Painted X Walk1?	No
				X Walk 1 Direction	To NE
			N/A	X Walk 1 Width (in)	N/A
				X Walk 1 Slope (%)	0.5
				X Walk 1 X Slope (%)	1.4
			N/A	Ramp inside XWalk1?	N/A

Road Slope (%)	N/A
				Road X Slope (%)	N/A
			N/A	Any Obstructions?	N/A
				Obstruction Type	
Total Cost: \$ 1850.00			N/A		N/A
			Yes	Surface Condition? (G/P)	Good
