# Access Compliance Report

## Public Rights-of-Way

### (Curb Ramps)

| Intersection ID: 8904 | Main Street: FAIRMONT_ST | Cross Street: RUSSELL_AV | Location: SE |

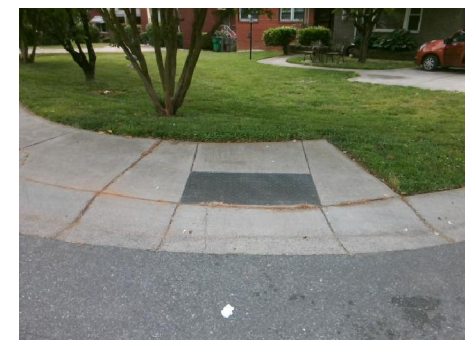
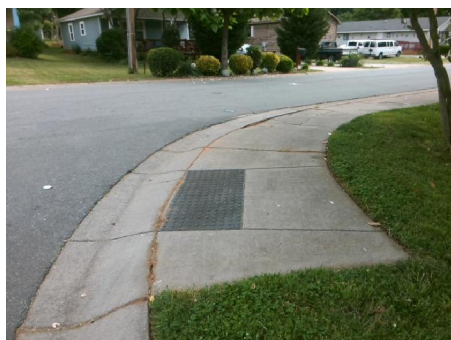
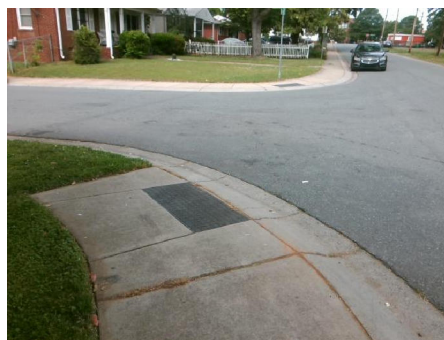
| ADA ID: 2F044F176DC7 | Ramp Type: BlendTrans1 | Initial Pass/Fail: Fail | Overall Compliance: No |

**NO RT SW**

**Not Found, R304.5.3**

| Compliance | Description | Data | Compliance | Description | Data |
|---|---|---|---|---|---|
| Yes | Ramp Width (in) | 48.0 | No | BlendTrans XSlope (%) | 3.3 |
| | | | No | Curb Slope (%) | 20.0 |

**Remove & Replace Curb Ramp With Two New Directional Ramps or Equivalent.**
