Access Compliance Report Public Rights-of-Way (Curb Ramps)

Intersection ID: N/A Main Street: BACK ACRE DR Cross Street: SAWMILL TRACE DR Location: NW 0 ADA ID: 2F293512006D Ramp Type: Combination1Diag Initial Pass/Fail: Fail **Overall Compliance: No Severity Score:**

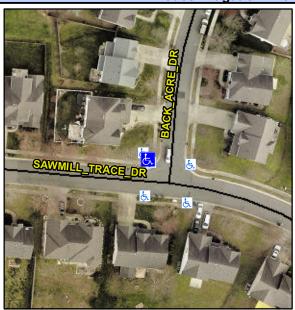
None **SAWMILL TRACE DR** StopSign **BACK ACRE DR** Possible Solutions: Remove & Replace Curb Ramp With Two New Directional Ramps or Equivalent. Surveyor Notes: N/A PROW/ADA: Not Found, R304.5.1, R304.5.1, R304.2.2, R304.5.3, R304.3.2
