# Access Compliance Report

## Public Rights-of-Way

### (Curb Ramps)

| Intersection ID: 8391 | Main Street: LASALLE_ST | Cross Street: MADRID_ST | Location: SW |

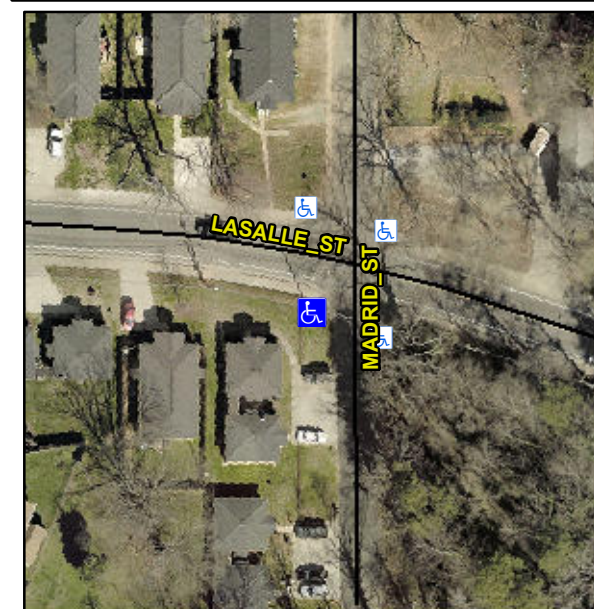
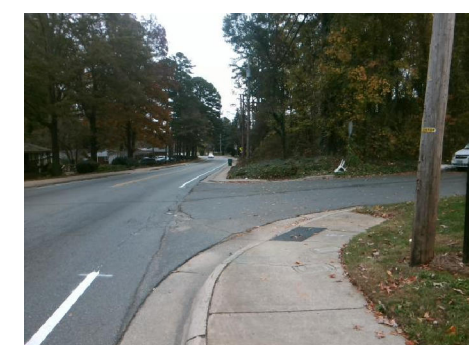
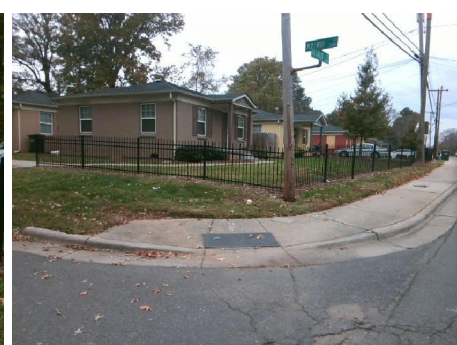
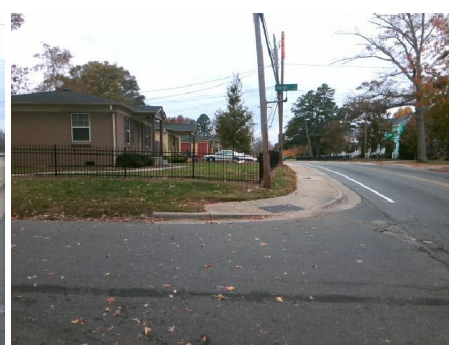
**Not Found, R304.5.1, R304.2.2**

| Compliance | Description | Data | Compliance | Description | Data |
|---|---|---|---|---|---|
| N/A | Ramp Length (in) | 60.0 | No | Ramp Slope (%) | 12.0 |
| No | Ramp Width (in) | 34.0 | Yes | Ramp XSlope (%) | 1.9 |

**Remove & Replace Curb Ramp With Two New Directional Ramps or Equivalent.**
