Access Compliance Report Public Rights-of-Way (Curb Ramps)

Intersection ID: 20540Main Street: FAIRVIEW_RDCross Street: VALENCIA_TRLocation:SEADA ID: 2F6CFBEE4B9FRamp Type: PerpInitial Pass/Fail: FailOverall Compliance: NoSeverity Score:25

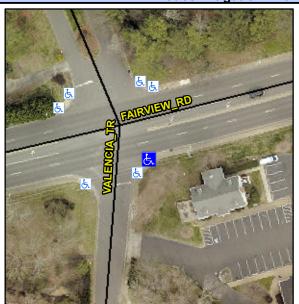
Field Measurements/Component Compliance								
Comp	liance Description	Data	Comp	liance	Description	Data		
N/A	Ramp Length (in)	60.0	Yes	Ramp	Slope (%)	7.7		
Yes	Ramp Width (in)	48.0	No	Ramp	XSlope (%)	7.2		
N/A	Flare Type LT	N/A	N/A	Flare	Type RT	N/A		
N/A	Flare Slope LT (%)	N/A	N/A	Flare	Slope RT (%)	N/A		
N/A	Flare Traversable LT?	N/A	N/A	Flare	Traversable RT?	N/A		
N/A	Landing Length (in)	N/A	N/A	DWS	Provided?	N/A		
N/A	Landing Width (in)	N/A	N/A	DWS	Contrast?	N/A		
N/A	Landing Slope (%)	N/A	N/A	DWS	Length (in)	N/A		
N/A	Landing X Slope (%)	N/A	N/A	DWS	Full Width?	N/A		
N/A	Landing Curb? (Y/N)	N/A	N/A	DWS	Offset (in)	N/A		
N/A	Shared Landing?	N/A						
N/A	Gutter Ponding?	N/A	N/A	Gutte	r Slope (%)	N/A		
N/A	Gutter Lip Ht (in)	N/A	N/A	Gutte	r X Slope (%)	N/A		
N/A	Painted X Walk1?	No	N/A	Painte	ed X Walk2?	N/A		
	X Walk 1 Direction	To NE		X Wa	lk 2 Direction	N/A		
N/A	X Walk 1 Width (in)	N/A	N/A	X Wa	lk 2 Width (in)	N/A

X Walk 1 Slope (%)	4.3		X Wa	lk 2 Slope (%)	N/A		
	X Walk 1 X Slope (%)	3.1		X Wa	lk 2 X Slope (%)	N/A		
N/A	Ramp inside XWalk1?	N/A	N/A	Ramp	inside XWalk2?	N/A		
	Road Slope (%)	N/A	N/A	Clear	Space?	N/A		
	Road X Slope (%)	N/A	N/A	Clear	Space to XWalk (in)	N/A		
N/A	Any Obstructions?	N/A	N/A	Storm	Grate/Utility Hazard?	N/A		
	Obstruction Type			Storm	Grate/Utility Type			
		N/A				N/A		
			Yes	Surfa	ce Condition? (G/P)	Good		
	· ·

Possible Solutions:	9	
Remove & Replace Entire Ramp.		
	Y	
	N	
	N	
	N	
	N	
Surveyor Notes:	N	
N/A	N	
	N	
	N	
	N	
PROW/ADA:	N	
Not Found, R304.5.3	N	
	N	
	N
