## Access Compliance Report Public Rights-of-Way (Curb Ramps)

Intersection ID: 25066Main Street:BIRNEN\_DRCross Street:PARK\_RDLocation:NEADA ID: 2FA0A44C7B97Ramp Type:PerpDiagInitial Pass/Fail:FailOverall Compliance:NoSeverity Score:26.25

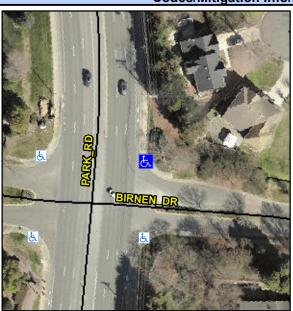
Not Found, R304.2.2, R304.5.3

Compl	iance Description	Data	Compliance Description		Data
N/A	Ramp Length (in)	60.0	No	Ramp Slope (%)	12.3
Yes	Ramp Width (in)	48.0	No	Ramp XSlope (%)	4.4
N/A	Flare Type LT	N/A	N/A	Flare Type RT	N/A
N/A	Flare Slope LT (%)	N/A	N/A	Flare Slope RT (%)	N/A
N/A	Flare Traversable LT?	N/A	N/A	Flare Traversable RT?	N/A
N/A	Landing Length (in)	N/A	N/A	DWS Provided?	N/A
N/A	Landing Width (in)	N/A	N/A	DWS Contrast?	N/A
N/A	Landing Slope (%)	N/A	N/A	DWS Length (in)	N/A
N/A	Landing X Slope (%)	N/A	N/A	DWS Full Width?	N/A
N/A	Landing Curb? (Y/N)	N/A	N/A	DWS Offset (in)	N/A
N/A	Shared Landing?	N/A	IN/A	DVV3 Oliset (III)	IV/A
N/A	· ·	N/A N/A	N/A	Cuttor Clana (0/)	N/A
	Gutter Ponding?		l	Gutter Slope (%)	
N/A	Gutter Lip Ht (in)	N/A	N/A	Gutter X Slope (%)	N/A
N/A	Painted X Walk1?	No	N/A	Painted X Walk2?	No
	X Walk 1 Direction	To NW		X Walk 2 Direction	To SW
N/A	X Walk 1 Width (in)	N/A	N/A	X Walk 2 Width (in)	N/A
	X Walk 1 Slope (%)	3.3		X Walk 2 Slope (%)	0.1

Remove & Replace Curb Ramp With Two New Directional Ramps or Equivalent.
