Access Compliance Report

Public Rights-of-Way

(Curb Ramps)

Intersection ID: 53965	Main Street: MAGNOLIA LILY AV	Cross Street: SPRING SPRUCE LN	Location: SE
ADA ID: 2FB16F8352E8	Ramp Type: Perp	Initial Pass/Fail: Fail	Overall Compliance: No
Severity Score: 10			
Codes/Mitigation Info/Possible Solution		Field Measurements/Component Compliance

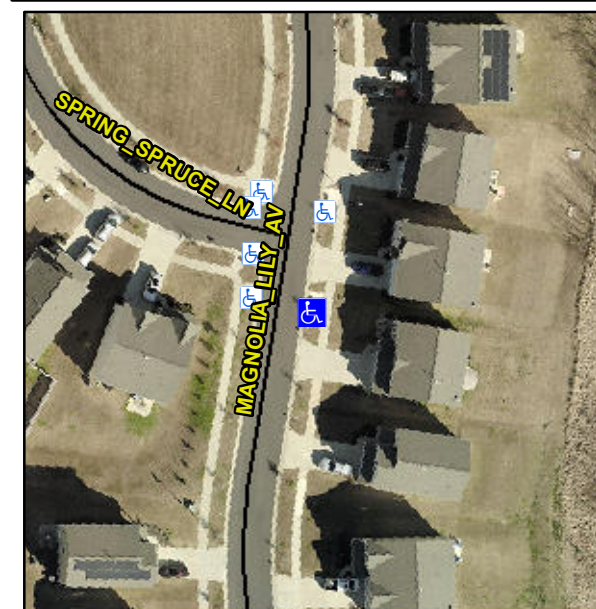
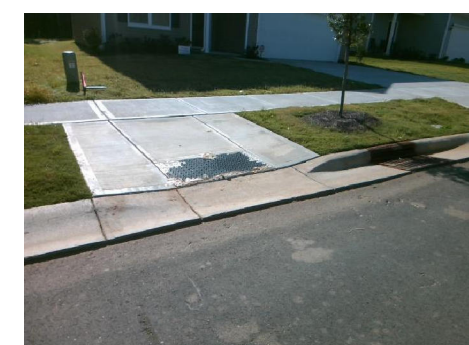
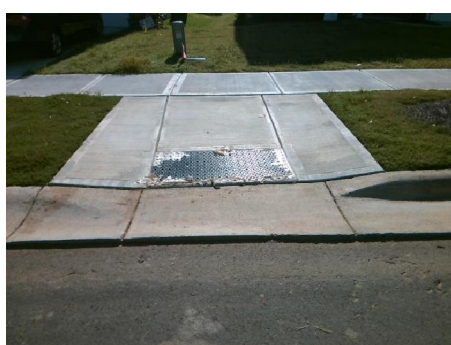
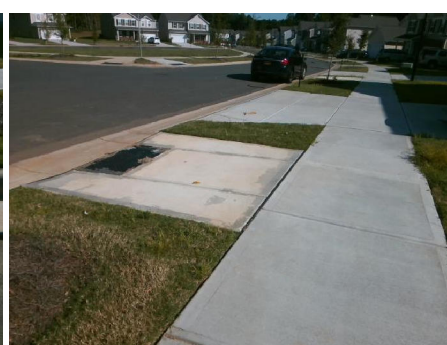
Not Found, R304.5.1

Compliance	Description	Data	Compliance	Description	Data
N/A	Ramp Length (in)	95.0	Yes	Ramp Slope (%)	6.0
No	Ramp Width (in)	47.0	Yes	Ramp XSlope (%)	3.1
N/A	Flare Type LT	N/A	N/A	Flare Type RT	N/A
N/A	Flare Slope LT (%)	N/A	N/A	Flare Slope RT (%)	N/A
N/A	Flare Traversable LT?	N/A	N/A	Flare Traversable RT?	N/A
N/A	Landing Length (in)	N/A	N/A	DWS Provided?	N/A
N/A	Landing Width (in)	N/A	N/A	DWS Contrast?	N/A
N/A	Landing Slope (%)	N/A	N/A	DWS Length (in)	N/A
N/A	Landing X Slope (%)	N/A	N/A	DWS Full Width?	N/A
N/A	Landing Curb? (Y/N)	N/A	N/A	DWS Offset (in)	N/A
N/A	Shared Landing?	N/A			
N/A	Gutter Ponding?	N/A	N/A	Gutter Slope (%)	N/A
N/A	Gutter Lip Ht (in)	1.0	N/A	Gutter X Slope (%)	N/A
N/A	Painted X Walk1?	No	N/A	Painted X Walk2?	N/A
	X Walk 1 Direction	To W		X Walk 2 Direction	N/A
N/A	X Walk 1 Width (in)	N/A	N/A	X Walk 2 Width (in)	N/A
	X Walk 1 Slope (%)	2.8		X Walk 2 Slope (%)	N/A
	X Walk 1 X Slope (%)	3.6		X Walk 2 X Slope (%)	N/A

N/A	Ramp inside XWalk1?	N/A	N/A	Ramp inside XWalk2?	N/A
	Road Slope (%)	N/A	N/A	Clear Space?	N/A
	Road X Slope (%)	N/A	N/A	Clear Space to XWalk (in)	N/A
N/A	Any Obstructions?	N/A	N/A	Storm Grate/Utility Hazard?	N/A
	Obstruction Type			Storm Grate/Utility Type	
		N/A			N/A
			Yes	Surface Condition? (G/P)	Good

Remove & Replace Entire Ramp.
