Access Compliance Report

Public Rights-of-Way

(Curb Ramps)

Intersection ID: 8037	Main Street: AUSTIN_DR	Cross Street: ELGYWOOD_LN	Location: NE
ADA ID: 2FEC614FE9F9	Ramp Type: Para	Initial Pass/Fail: Fail	Overall Compliance: No
			Severity Score: 13.75

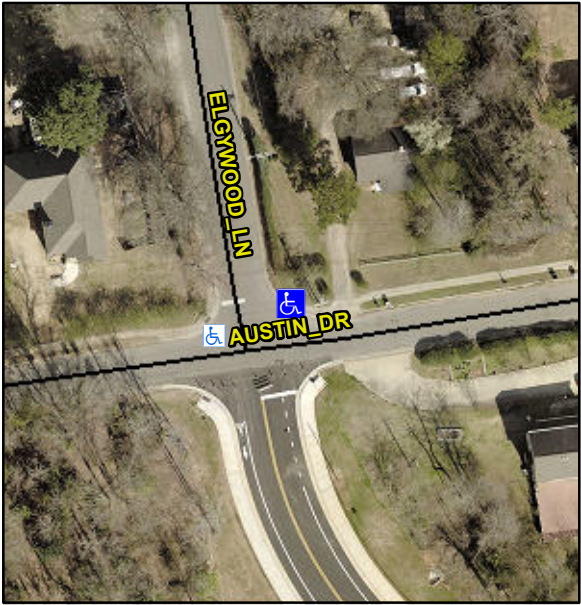
Possible Solutions:		Compliance	Description	Data
	Remove & Replace Entire Ramp.		N/A	Ramp Length LT (in)	23.5
			Yes	Ramp Width LT (in)	63.0
			No	Ramp Slope LT (%)	10.0
			No	Ramp XSlope LT (%)	2.5
			N/A	Landing Length (in)	N/A
			N/A	Landing Width (in)	N/A
			N/A	Landing Slope (%)	N/A
			N/A	Landing X Slope (%)	N/A
			N/A	Landing Curb? (Y/N)	N/A
<p>Surveyor Notes:</p> <p>RT RP < 5%, NO LT SW</p> <p>PROW/ADA:</p> <p>R304.3.2, R304.5.3</p>			N/A	Shared Landing?	N/A
			N/A	Gutter Ponding?	N/A
			N/A	Gutter Lip Ht (in)	N/A
			N/A	Painted X Walk1?	No
				X Walk 1 Direction	To W
			N/A	X Walk 1 Width (in)	N/A
				X Walk 1 Slope (%)	1.2
				X Walk 1 X Slope (%)	4.4
			N/A	Ramp inside XWalk1?	N/A
				Road Slope (%)	N/A
<p>Total Cost:</p> <p>\$ 1600.00</p>			N/A	Road X Slope (%)	N/A
			N/A	Any Obstructions?	N/A
				Obstruction Type

N/A		
<p>Street 1 Name</p> <p>ELGYWOOD LN</p> <p>Stop Condition-Street 1</p> <p>StopSign</p> <p>Street 2 Name</p> <p>N/A</p> <p>Stop Condition-Street 2</p> <p>N/A</p>			N/A	Storm Grate/Utility Hazard?	N/A
				Storm Grate/Utility Type	
			N/A		
			Yes	Surface Condition? (G/P)	Good
			N/A	Curb Slope (%)	29.8
