Access Compliance Report

Public Rights-of-Way

(Curb Ramps)

Intersection ID: 14028	Main Street: JAMES_ST	Cross Street: WEST_BV	Location: NW
ADA ID: 306ACEBC37C4	Ramp Type: Combination1Diag	Initial Pass/Fail: Fail	Overall Compliance: No
		Severity Score: 0

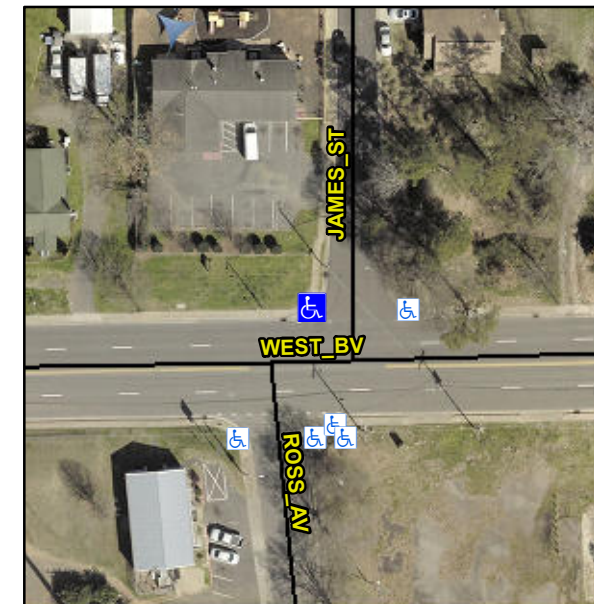
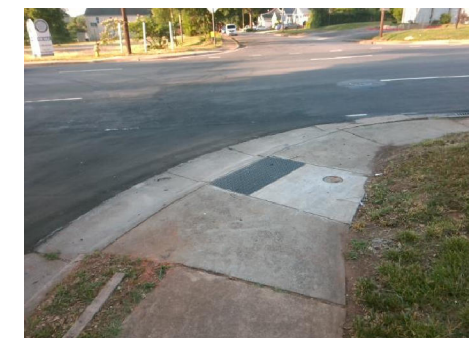
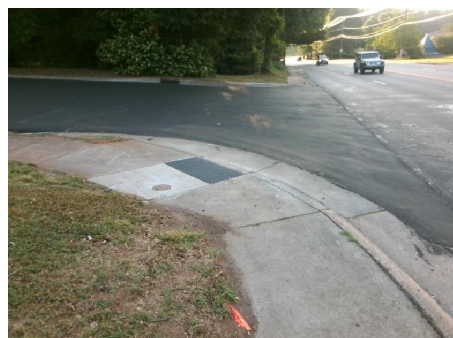
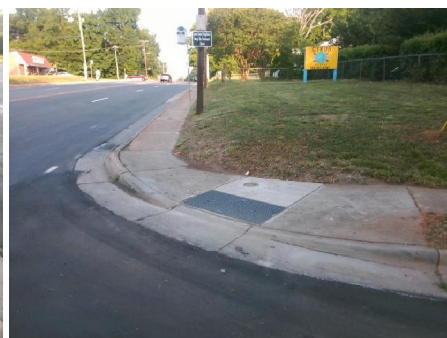
Not Found, R304.5.1, R304.5.3, R304.3.2

Compliance	Description	Data	Compliance	Description	Data
N/A	Ramp Length LT (in)	43.0	N/A	Ramp Length RT (in)	42.0
Yes	Ramp Width LT (in)	51.0	Yes	Ramp Width RT (in)	74.5
Yes	Ramp Slope LT (%)	5.1	No	Ramp Slope RT (%)	10.1
No	Ramp XSlope LT (%)	3.9	No	Ramp XSlope RT (%)	3.3
N/A	Ramp Length (in)	61.0	Yes	Ramp Slope (%)	6.8
No	Ramp Width (in)	44.0	Yes	Ramp XSlope (%)	1.1
N/A	Flare Type LT	N/A	N/A	Flare Type RT	N/A
N/A	Flare Slope LT (%)	N/A	N/A	Flare Slope RT (%)	N/A
N/A	Flare Traversable LT?	N/A	N/A	Flare Traversable RT?	N/A
N/A	Landing Length (in)	N/A	N/A	DWS Provided?	N/A
N/A	Landing Width (in)	N/A	N/A	DWS Contrast?	N/A
N/A	Landing Slope (%)	N/A	N/A	DWS Length (in)	N/A
N/A	Landing X Slope (%)	N/A	N/A	DWS Full Width?	N/A
N/A	Landing Curb? (Y/N)	N/A	N/A	DWS Offset (in)	N/A
N/A	Shared Landing?	N/A			
N/A	Gutter Ponding?	N/A	N/A	Gutter Slope (%)	N/A
N/A	Gutter Lip Ht (in)	N/A	N/A	Gutter X Slope (%)	N/A
N/A	Painted X Walk1?	No	N/A	Painted X Walk2?	No

Remove & Replace Curb Ramp With Two New Directional Ramps or Equivalent.
