Access Compliance Report Public Rights-of-Way (Curb Ramps)

Intersection ID: 30433 Main Street: CEDAR_ROCK_DR Cross Street: NANNYBERRY_LN Location: SE

ADA ID: 30B40A0BB816 Ramp Type: PerpDiag Initial Pass/Fail: Fail Overall Compliance: No Severity Score: 22.5

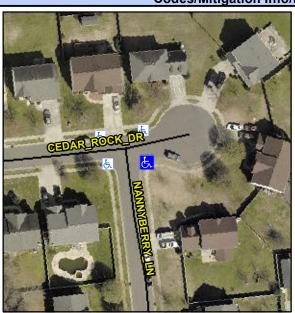
Field Measurements/Component Compnance					
Compliance Description		Data	Compliance Description		Data
N/A	Ramp Length (in)	42.0	No	Ramp Slope (%)	8.4
No	Ramp Width (in)	46.0	No	Ramp XSlope (%)	4.0
N/A	Flare Type LT	N/A	N/A	Flare Type RT	N/A
N/A	Flare Slope LT (%)	N/A	N/A	Flare Slope RT (%)	N/A
N/A	Flare Traversable LT?	N/A	N/A	Flare Traversable RT?	N/A
N/A	Landing Length (in)	N/A	N/A	DWS Provided?	N/A
N/A	Landing Width (in)	N/A	N/A	DWS Contrast?	N/A
N/A	Landing Slope (%)	N/A	N/A	DWS Length (in)	N/A
N/A	Landing X Slope (%)	N/A	N/A	DWS Full Width?	N/A
N/A	Landing Curb? (Y/N)	N/A	N/A	DWS Offset (in)	N/A
N/A	Shared Landing?	N/A			
N/A	Gutter Ponding?	N/A	N/A	Gutter Slope (%)	N/A
N/A	Gutter Lip Ht (in)	N/A	N/A	Gutter X Slope (%)	N/A
N/A	Painted X Walk1?	No	N/A	Painted X Walk2?	No
	X Walk 1 Direction	To N		X Walk 2 Direction	To W
N/A	X Walk 1 Width (in)	N/A	N/A	X Walk 2 Width (in)	N/A
	X Walk 1 Slope (%)	2.3		X Walk 2 Slope (%)	0.3

X Walk 1 X Slope (%)	2.2		X Walk 2 X Slope (%)	4.0
N/A	Ramp inside XWalk1?	N/A	N/A	Ramp inside XWalk2?	N/A
	Road Slope (%)	3.3	N/A	Clear Space?	N/A
	Road X Slope (%)	2.0	N/A	Clear Space to XWalk (in)	N/A
N/A	Any Obstructions?	N/A	N/A	Storm Grate/Utility Hazard?	N/A
	Obstruction Type			Storm Grate/Utility Type	
		N/A			N/A
			Yes	Surface Condition? (G/P)	Good

Remove & Replace Curb Ramp With
Two New Directional Ramps or
Equivalent.
