Access Compliance Report Public Rights-of-Way (Curb Ramps)

Intersection ID: 22474 Main Street: DENMARK RD Cross Street: E_HEBRON_ST Location: NW ADA ID: 310D8274EFF7 Ramp Type: PerpDiag Initial Pass/Fail: Fail **Overall Compliance: No Severity Score:** 25

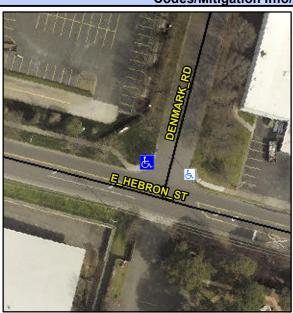
E HEBRON ST Street 1 Name Stop Condition-Street 2 Street 2 Name **DENMARK RD** Stop Condition-Street 1 StopSign Possible Solutions: Remove & Replace Curb Ramp With Two New Directional Ramps or Equivalent. Surveyor Notes: N/A PROW/ADA: Not Found, R304.5.3

| Field Measurements/Component Compliance | | | | | |
|---|---|---|---|---|---|
| Yes | Ramp Width (in) | 48.0 | No | Ramp XSlope (%) | 7.6 |
