# Access Compliance Report

## Public Rights-of-Way

### (Curb Ramps)

Intersection ID: 8714	Main Street: LASALLE_ST	Cross Street: CELIA_AV	Location:	N
ADA ID: 31763D40E6A0	Ramp Type: Perp	Initial Pass/Fail: Fail	Overall Compliance: No	Severity Score: 13.75

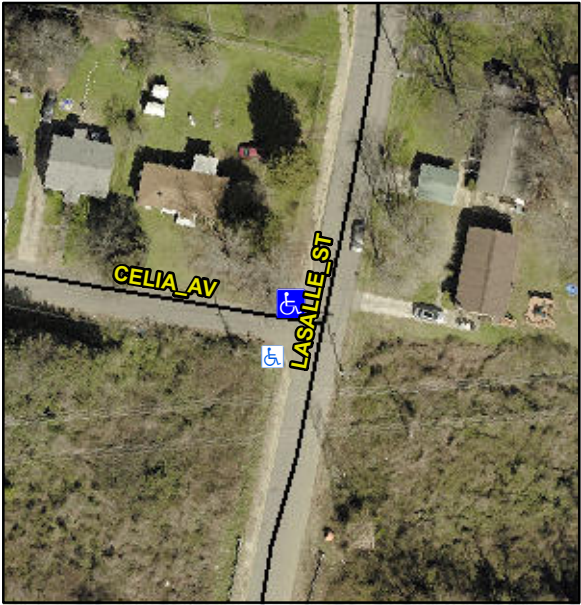
Possible Solutions:		<b>Compliance</b>	<b>Description</b>	<b>Data</b>
	Remove & Replace Entire Ramp.		N/A	Ramp Length (in)	59.5
			Yes	Ramp Width (in)	87.0
			N/A	Flare Type LT	N/A
			N/A	Flare Slope LT (%)	N/A
			N/A	Flare Traversable LT?	N/A
			N/A	Landing Length (in)	N/A
			N/A	Landing Width (in)	N/A
			N/A	Landing Slope (%)	N/A
			N/A	Landing X Slope (%)	N/A
<p>Surveyor Notes:</p> <p>N/A</p> <p>PROW/ADA:</p> <p>Not Found, R304.2.2, R304.5.3</p>			N/A	Flare Type RT	N/A
			N/A	Flare Slope RT (%)	N/A
			N/A	Flare Traversable RT?	N/A
			N/A	DWS Provided?	N/A
			N/A	DWS Contrast?	N/A
			N/A	DWS Length (in)	N/A
			N/A	DWS Full Width?	N/A
			N/A	DWS Offset (in)	N/A
			N/A	Shared Landing?	N/A
			N/A	Gutter Ponding?	Yes
			N/A	Gutter Lip Ht (in)	N/A
			N/A	Painted X Walk1?	No
				X Walk 1 Direction	To SW
			N/A	X Walk 1 Width (in)	N/A

X Walk 1 Slope (%)	2.1
				X Walk 1 X Slope (%)	2.4
			N/A	Ramp inside XWalk1?	N/A
			N/A	Road Slope (%)	N/A
			N/A	Road X Slope (%)	N/A
			N/A	Any Obstructions?	N/A
				Obstruction Type	
Total Cost:		\$ 1850.00			
			N/A		N/A
			Yes	Surface Condition? (G/P)	Good
