# Access Compliance Report

## Public Rights-of-Way

### (Curb Ramps)

Intersection ID: 9129	Main Street: N_GRAHAM_ST	Cross Street: NORRIS_AV	Location: SE
ADA ID: 329E0776D486	Ramp Type: Combination1	Initial Pass/Fail: Fail	Overall Compliance: No
Codes/Mitigation Info/Possible Solution		Field Measurements/Component Compliance	
Severity Score: 22.5

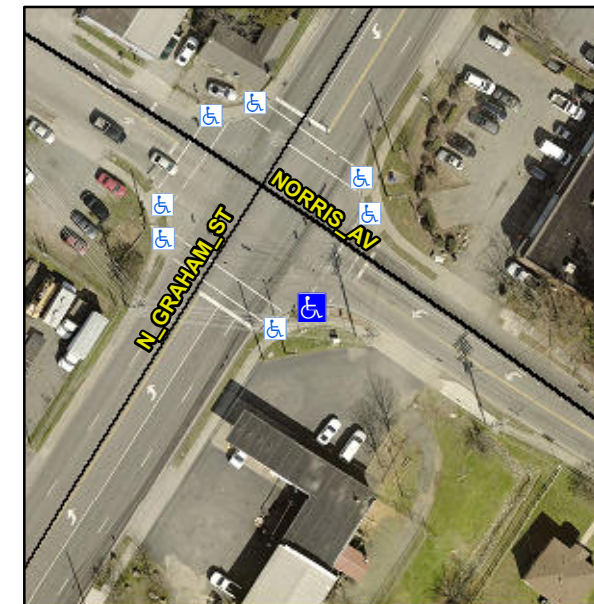
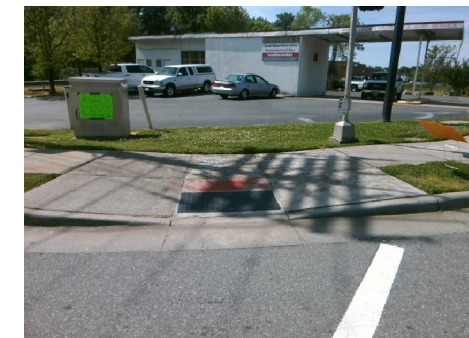
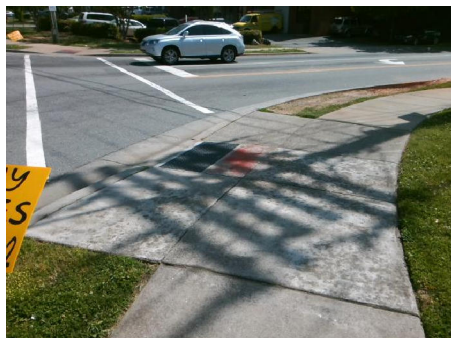
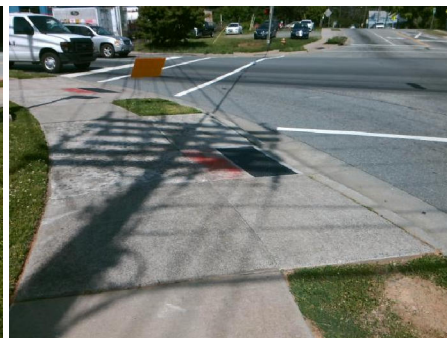
**LT RP < 5%**

**Not Found, R304.5.1, R304.5.3, R304.3.2**

Compliance	Description	Data	Compliance	Description	Data
N/A	Ramp Length LT (in)	55.0	N/A	Ramp Length RT (in)	61.0
Yes	Ramp Width LT (in)	60.0	Yes	Ramp Width RT (in)	60.0
Yes	Ramp Slope LT (%)	1.1	No	Ramp Slope RT (%)	9.3
No	Ramp XSlope LT (%)	2.5	Yes	Ramp XSlope RT (%)	1.4
N/A	Ramp Length (in)	48.5	Yes	Ramp Slope (%)	6.3
No	Ramp Width (in)	47.0	No	Ramp XSlope (%)	2.4
N/A	Flare Type LT	N/A	N/A	Flare Type RT	N/A
N/A	Flare Slope LT (%)	N/A	N/A	Flare Slope RT (%)	N/A
N/A	Flare Traversable LT?	N/A	N/A	Flare Traversable RT?	N/A
N/A	Landing Length (in)	N/A	N/A	DWS Provided?	N/A
N/A	Landing Width (in)	N/A	N/A	DWS Contrast?	N/A
N/A	Landing Slope (%)	N/A	N/A	DWS Length (in)	N/A
N/A	Landing X Slope (%)	N/A	N/A	DWS Full Width?	N/A
N/A	Landing Curb? (Y/N)	N/A	N/A	DWS Offset (in)	N/A
N/A	Shared Landing?	N/A			
N/A	Gutter Ponding?	N/A	N/A	Gutter Slope (%)	N/A
N/A	Gutter Lip Ht (in)	N/A	N/A	Gutter X Slope (%)	N/A
N/A	Painted X Walk1?	Yes	N/A	Painted X Walk2?	N/A

**Remove & Replace Entire Ramp.**
