# Access Compliance Report

## Public Rights-of-Way

### (Curb Ramps)

Intersection ID: 3071	Main Street: BLACK_MAPLE_AV	Cross Street: NORWAY_CT	Location:	N
ADA ID: 32B8FF9DC4AD	Ramp Type: Perp	Initial Pass/Fail: Fail	Overall Compliance: No	Severity Score: 10

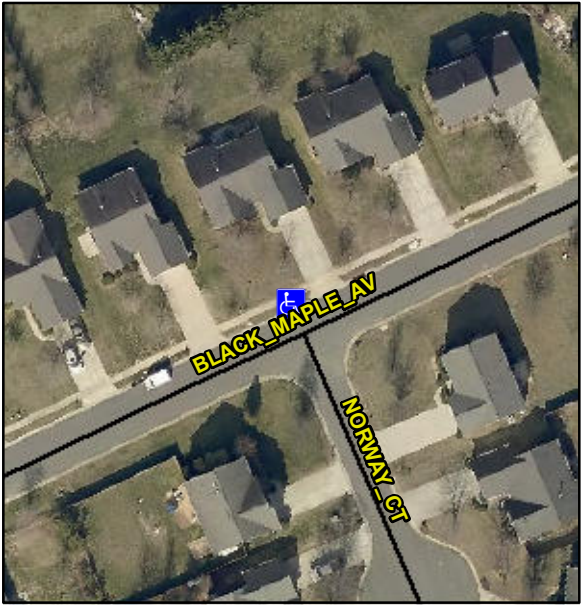
Possible Solutions:		<b>Compliance</b>	<b>Description</b>	<b>Data</b>	
	<b>Remove &amp; Replace Entire Ramp.</b>		<b>N/A</b>	Ramp Length (in)	<b>50.5</b>	<b>Yes</b>
			<b>No</b>	Ramp Width (in)	<b>46.0</b>	<b>Yes</b>
			<b>N/A</b>	Flare Type LT	<b>N/A</b>	<b>N/A</b>
			<b>N/A</b>	Flare Slope LT (%)	<b>N/A</b>	<b>N/A</b>
			<b>N/A</b>	Flare Traversable LT?	<b>N/A</b>	<b>N/A</b>
			<b>N/A</b>	Landing Length (in)	<b>N/A</b>	<b>N/A</b>
			<b>N/A</b>	Landing Width (in)	<b>N/A</b>	<b>N/A</b>
			<b>N/A</b>	Landing Slope (%)	<b>N/A</b>	<b>N/A</b>
			<b>N/A</b>	Landing X Slope (%)	<b>N/A</b>	<b>N/A</b>
<p>Surveyor Notes:</p> <p><b>N/A</b></p> <p>PROW/ADA:</p> <p><b>Not Found, R304.5.1</b></p>			<b>N/A</b>	Landing Curb? (Y/N)	<b>N/A</b>	<b>N/A</b>
			<b>N/A</b>	Shared Landing?	<b>N/A</b>	
			<b>N/A</b>	Gutter Ponding?	<b>Yes</b>	<b>N/A</b>

<b>N/A</b>	Gutter Lip Ht (in)	<b>N/A</b>	<b>N/A</b>
			<b>N/A</b>	Painted X Walk1?	<b>No</b>	<b>N/A</b>
				X Walk 1 Direction	<b>To S</b>	
			<b>N/A</b>	X Walk 1 Width (in)	<b>N/A</b>	<b>N/A</b>
				X Walk 1 Slope (%)	<b>6.0</b>	
				X Walk 1 X Slope (%)	<b>3.0</b>	
			<b>N/A</b>	Ramp inside XWalk1?	<b>N/A</b>	<b>N/A</b>
<p>Street 1 Name</p> <p>Stop Condition-Street 2</p> <p>Street 2 Name</p> <p>Stop Condition-Street 1</p>			<b>N/A</b>	Road Slope (%)	<b>N/A</b>	<b>N/A</b>
				Road X Slope (%)	<b>N/A</b>	<b>N/A</b>
			<b>N/A</b>	Any Obstructions?	<b>N/A</b>	<b>N/A</b>
				Obstruction Type		
Total Cost:		\$ 1850.00				
			<b>N/A</b>			<b>N/A</b>
			<b>Yes</b>	Surface Condition? (G/P)		<b>Good</b>
