# Access Compliance Report

## Public Rights-of-Way

### (Curb Ramps)

| Intersection ID: 11460 | Main Street: PALM_AV | Cross Street: CARDIFF_AV | Location: SE |

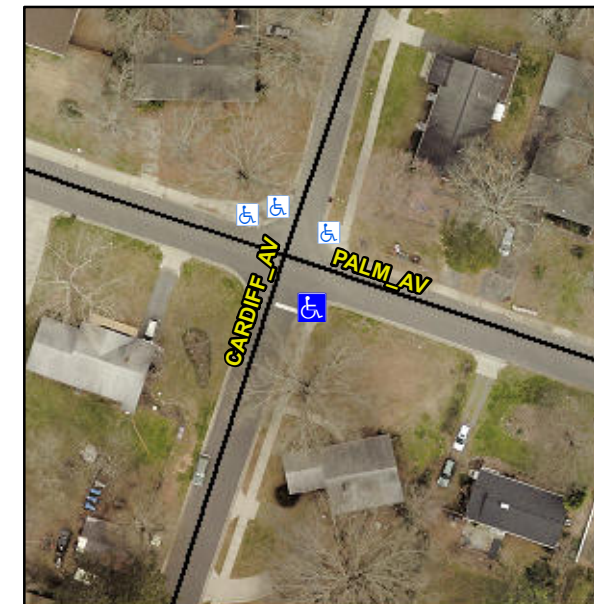
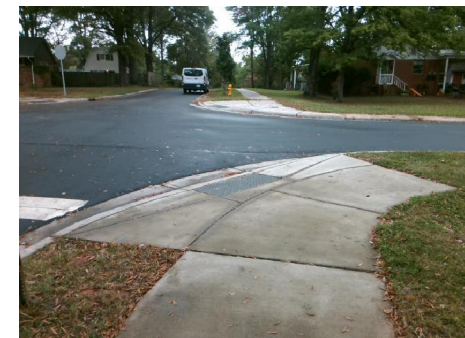
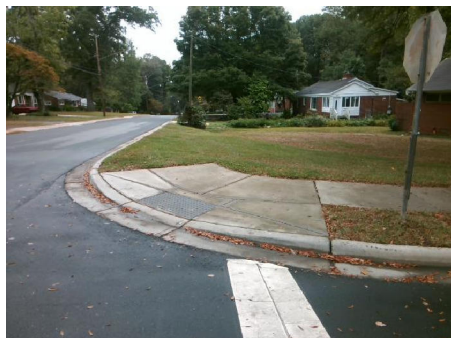
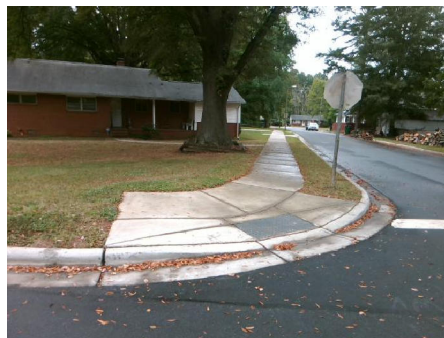
| ADA ID: 32C02EDEADE5 | Ramp Type: BlendTrans1 | Initial Pass/Fail: Fail | Overall Compliance: No |

**Not Found, R304.5.1**

| Compliance | Description | Data | Compliance | Description | Data |
|---|---|---|---|---|---|
| No | Ramp Width (in) | 46.5 | Yes | BlendTrans XSlope (%) | 2.6 |
| | | | No | Curb Slope (%) | 17.0 |

**Remove & Replace Curb Ramp With Two New Directional Ramps or Equivalent.**
