## Access Compliance Report Public Rights-of-Way (Curb Ramps)

Intersection ID: 52536Main Street: VINOY\_BVCross Street: IBM\_DRLocation:SWADA ID: 3340BE8A0894Ramp Type: PerpDiagInitial Pass/Fail: FailOverall Compliance: NoSeverity Score:35

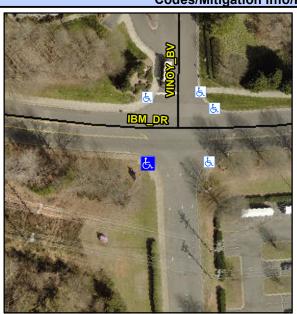
Not Found, R304.5.1, R304.2.2, R304.5.3

Field Measurements/Component Compliance						
	Compliance Description		Data	Comp	liance Description	Data
	N/A	Ramp Length (in)	64.0	No	Ramp Slope (%)	12.6
	No	Ramp Width (in)	40.0	No	Ramp XSlope (%)	2.3
	N/A	Flare Type LT	N/A	N/A	Flare Type RT	N/A
	N/A	Flare Slope LT (%)	N/A	N/A	Flare Slope RT (%)	N/A
	N/A	Flare Traversable LT?	N/A	N/A	Flare Traversable RT?	N/A
	N/A	Landing Length (in)	N/A	N/A	DWS Provided?	N/A
	N/A	Landing Width (in)	N/A	N/A	DWS Contrast?	N/A
	N/A	Landing Slope (%)	N/A	N/A	DWS Length (in)	N/A
	N/A	Landing X Slope (%)	N/A	N/A	DWS Full Width?	N/A
	N/A	Landing Curb? (Y/N)	N/A	N/A	DWS Offset (in)	N/A
	N/A	Shared Landing?	N/A			
	N/A	Gutter Ponding?	N/A	N/A	Gutter Slope (%)	N/A
	N/A	Gutter Lip Ht (in)	1.5	N/A	Gutter X Slope (%)	N/A
	N/A	Painted X Walk1?	No	N/A	Painted X Walk2?	No
		X Walk 1 Direction	То Е		X Walk 2 Direction	To N
	N/A	X Walk 1 Width (in)	N/A	N/A	X Walk 2 Width (in)	N/A
		X Walk 1 Slope (%)	4.2		X Walk 2 Slope (%)	2.2

X Walk 1 X Slope (%)	0.5		X Walk 2 X Slope (%)	6.2
	N/A	Ramp inside XWalk1?	N/A	N/A	Ramp inside XWalk2?	N/A
		Road Slope (%)	2.7	N/A	Clear Space?	N/A
		Road X Slope (%)	4.8	N/A	Clear Space to XWalk (in)	N/A
	N/A	Any Obstructions?	N/A	N/A	Storm Grate/Utility Hazard?	N/A
		Obstruction Type			Storm Grate/Utility Type	
			N/A			N/A
				Yes	Surface Condition? (G/P)	Good

Remove & Replace Curb Ramp With Two New Directional Ramps or Equivalent.
