Access Compliance Report

Public Rights-of-Way

(Curb Ramps)

Intersection ID: 8512	Main Street: ISENHOUR_ST	Cross Street: MCARTHUR_AV	Location: SW
ADA ID: 338DEE0B304C	Ramp Type: Perp	Initial Pass/Fail: Fail	Overall Compliance: No
		Severity Score: 35

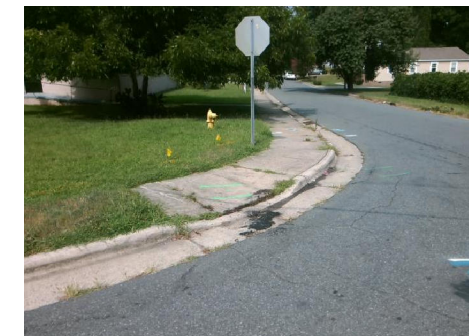
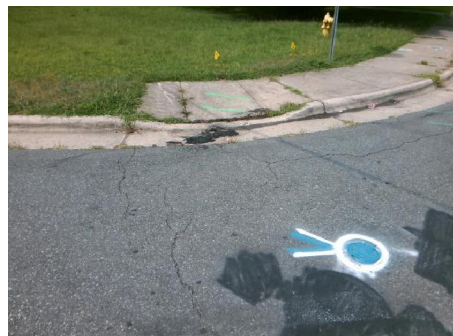
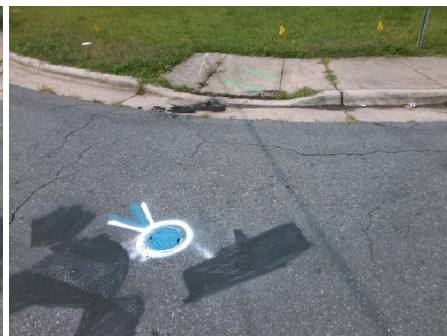
Not Found, R304.5.1, R304.2.2, R304.5.3

Compliance	Description	Data	Compliance	Description	Data
N/A	Ramp Length (in)	60.5	No	Ramp Slope (%)	13.4
No	Ramp Width (in)	37.0	No	Ramp XSlope (%)	3.2
N/A	Flare Type LT	N/A	N/A	Flare Type RT	N/A
N/A	Flare Slope LT (%)	N/A	N/A	Flare Slope RT (%)	N/A
N/A	Flare Traversable LT?	N/A	N/A	Flare Traversable RT?	N/A
N/A	Landing Length (in)	N/A	N/A	DWS Provided?	N/A
N/A	Landing Width (in)	N/A	N/A	DWS Contrast?	N/A
N/A	Landing Slope (%)	N/A	N/A	DWS Length (in)	N/A
N/A	Landing X Slope (%)	N/A	N/A	DWS Full Width?	N/A
N/A	Landing Curb? (Y/N)	N/A	N/A	DWS Offset (in)	N/A
N/A	Shared Landing?	N/A			
N/A	Gutter Ponding?	N/A	N/A	Gutter Slope (%)	N/A
N/A	Gutter Lip Ht (in)	N/A	N/A	Gutter X Slope (%)	N/A
N/A	Painted X Walk1?	No	N/A	Painted X Walk2?	N/A
	X Walk 1 Direction	To E		X Walk 2 Direction	N/A
N/A	X Walk 1 Width (in)	N/A	N/A	X Walk 2 Width (in)	N/A
	X Walk 1 Slope (%)	2.8		X Walk 2 Slope (%)	N/A
	X Walk 1 X Slope (%)	1.0		X Walk 2 X Slope (%)	N/A

Remove & Replace Entire Ramp.
