# Access Compliance Report

## Public Rights-of-Way (Curb Ramps)

| Intersection ID: 31304 | Main Street: WESTBEND_DR | Cross Street: ALEXANDER_POINTE_DR | Location: SW |
| ADA ID: 33A358B2A23D | Ramp Type: PerpDiag | Initial Pass/Fail: Fail | Overall Compliance: No |

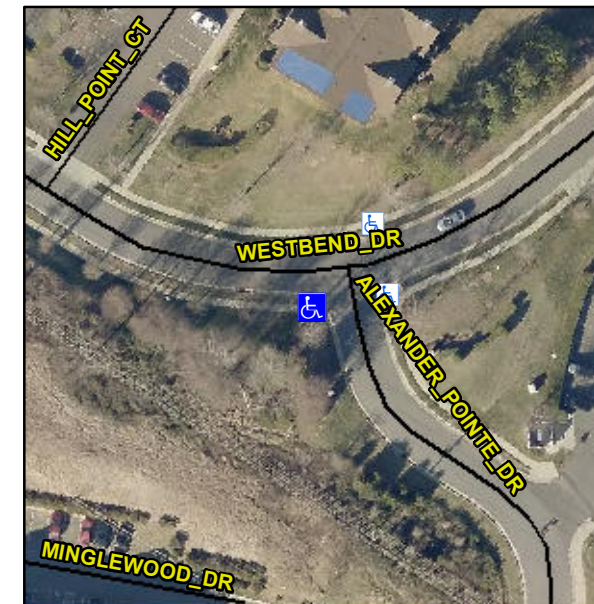
**R304.5.1, R304.2.2, R304.5.3**

| Compliance | Description | Data | Compliance | Description | Data |
|---|---|---|---|---|---|
| N/A | Ramp Length (in) | 48.0 | No | Ramp Slope (%) | 14.8 |
| No | Ramp Width (in) | 39.0 | No | Ramp XSlope (%) | 9.1 |

**Remove & Replace Curb Ramp With Two New Directional Ramps or Equivalent.**
