Access Compliance Report

Public Rights-of-Way

(Curb Ramps)

| Intersection ID: 3373 | Main Street: KATELYN_DR | Cross Street: PROSPERITY_CHURCH_RD | Location: E |

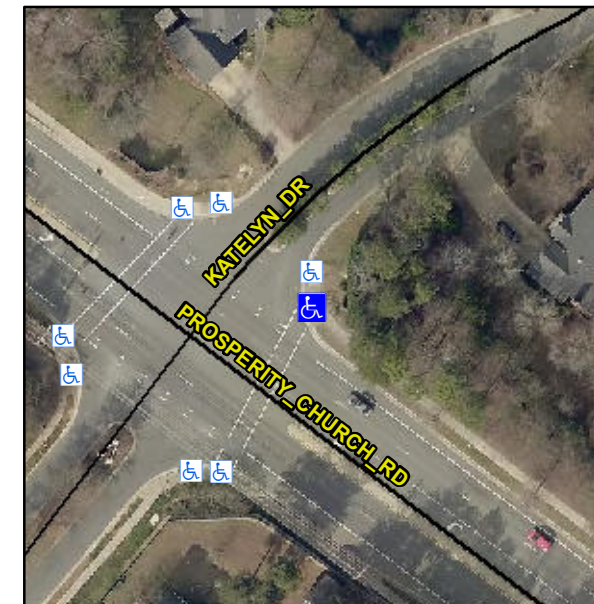
| ADA ID: 33AE3A32B19E | Ramp Type: Para | Initial Pass/Fail: Fail | Overall Compliance: No |
| Codes/Mitigation Info/Possible Solution | | | Severity Score: 25 |

LT RP < 5%

R304.3.2

| Compliance | Description | Data | Compliance | Description | Data |
|---|---|---|---|---|---|
| Yes | Ramp Slope LT (%) | 3.5 | No | Ramp Slope RT (%) | 12.5 |

Remove & Replace Entire Ramp.
