Access Compliance Report Public Rights-of-Way (Curb Ramps)

Intersection ID: 13561 Main Street: BAY ST **Cross Street: LAMAR AV** Location: **Overall Compliance: No ADA ID: 33CF3CCA86B8** Ramp Type: PerpDiag Initial Pass/Fail: Fail Severity Score: 13.75

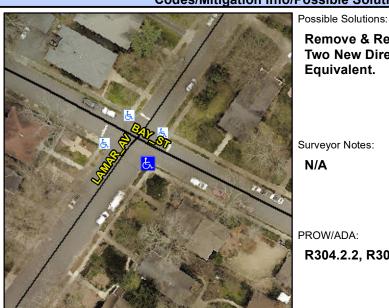
| Comp | liance | Description | Data | Com | oliance | Description | Data |
|---|---|---|---|---|---|---|---|
| N/A | Ramp | Length (in) | 48.0 | No | Ramp | Slope (%) | 8.7 |
| Yes | Ramp | o Width (in) | 70.0 | No | Ramp | XSlope (%) | 3.8 |
| N/A | Gutte | er Ponding? | Yes | N/A | Gutte | r Slope (%) | N/A |

Street 1 Name Stop Condition-Street 2 Street 2 Name Stop Condition-Street 1 Remove & Replace Curb Ramp With **Two New Directional Ramps or** Equivalent.

4.2.2, R304.5.3
