Access Compliance Report Public Rights-of-Way (Curb Ramps)

Intersection ID: 30360Main Street:TIMBERTOP_LNCross Street:WORLEY_DRLocation:NEADA ID: 3402A9DCA368Ramp Type:PerpDiagInitial Pass/Fail:FailOverall Compliance:NoSeverity Score:22.5

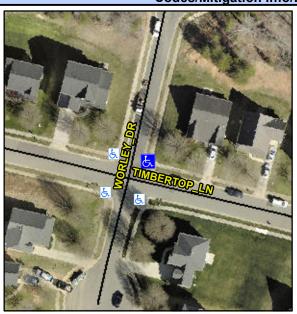
Not Found, R304.5.1, R304.2.2, R304.5.3

rield Measurements/Component Compilance							
	Compl	Compliance Description		Compliance Description		Data	
	N/A	Ramp Length (in)	44.0	No	Ramp Slope (%)	9.3	
	No	Ramp Width (in)	47.5	No	Ramp XSlope (%)	4.0	
	N/A	Flare Type LT	N/A	N/A	Flare Type RT	N/A	
	N/A	Flare Slope LT (%)	N/A	N/A	Flare Slope RT (%)	N/A	
	N/A	Flare Traversable LT?	N/A	N/A	Flare Traversable RT?	N/A	
	N/A	Landing Length (in)	N/A	N/A	DWS Provided?	N/A	
	N/A	Landing Width (in)	N/A	N/A	DWS Contrast?	N/A	
	N/A	Landing Slope (%)	N/A	N/A	DWS Length (in)	N/A	
	N/A	Landing X Slope (%)	N/A	N/A	DWS Full Width?	N/A	
	N/A	Landing Curb? (Y/N)	N/A	N/A	DWS Offset (in)	N/A	
	N/A	Shared Landing?	N/A				
	N/A	Gutter Ponding?	N/A	N/A	Gutter Slope (%)	N/A	
	N/A	Gutter Lip Ht (in)	N/A	N/A	Gutter X Slope (%)	N/A	
	N/A	Painted X Walk1?	No	N/A	Painted X Walk2?	No	
		X Walk 1 Direction	To NW		X Walk 2 Direction	To SW	
	N/A	X Walk 1 Width (in)	N/A	N/A	X Walk 2 Width (in)	N/A

X Walk 1 Slope (%)	5.8		X Walk 2 Slope (%)	6.6	
		X Walk 1 X Slope (%)	0.4		X Walk 2 X Slope (%)	7.7	
	N/A	Ramp inside XWalk1?	N/A	N/A	Ramp inside XWalk2?	N/A	
		Road Slope (%)	6.3	N/A	Clear Space?	N/A	
		Road X Slope (%)	3.6	N/A	Clear Space to XWalk (in)	N/A	
	N/A	Any Obstructions?	N/A	N/A	Storm Grate/Utility Hazard?	N/A	
		Obstruction Type			Storm Grate/Utility Type

Remove & Replace Curb Ramp With Two New Directional Ramps or Equivalent.
