Access Compliance Report Public Rights-of-Way (Curb Ramps)

Intersection ID: 10027867Main Street: HAMLIN_PARK_DRCross Street: N/ALocation:NEADA ID: 340B049CB7FFRamp Type: Directional1Initial Pass/Fail: FailOverall Compliance: NoSeverity Score: 1.25

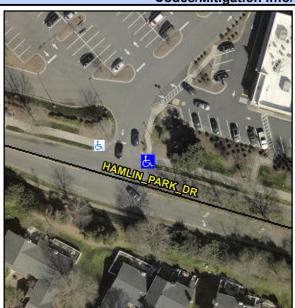
Field Measurements/Component Compliance						
Comp	liance Description	Data	Comp	liance Description	Data	
N/A	Ramp Length (in)	101.0	N/A	Grade Break?	N/A	
Yes	Ramp Width (in)	96.0	N/A	Grade Break Slope (%)	0.0	
Yes	Ramp Slope (%)	5.9	N/A	Grade Break XSlope (%)	0.0	
No	Ramp XSlope (%)	2.6				
N/A	Flare Type LT	N/A	N/A	Flare Type RT	N/A	
N/A	Flare Slope LT (%)	N/A	N/A	Flare Slope RT (%)	0.0	
N/A	Flare Traversable LT?	N/A	N/A	Flare Traversable RT?	N/A	
N/A	Landing Length (in)	0.0	N/A	DWS Provided?	N/A	
N/A	Landing Width (in)	0.0	N/A	DWS Contrast?	N/A	
N/A	Landing Slope (%)	0.0	N/A	DWS Length (in)	N/A	
N/A	Landing X Slope (%)	0.0	N/A	DWS Full Width?	N/A	
N/A	Landing Curb? (Y/N)	N/A	N/A	DWS Offset LT (in)	N/A	
N/A	Shared Landing?	N/A	N/A	DWS Offset RT (in)	N/A	
N/A	Gutter Ponding?	0.0	N/A	Gutter Slope (%)	N/A	
N/A	Gutter Lip Ht (in)	0.0	N/A	Gutter X Slope (%)	N/A	
N/A	Painted X Walk1?	No		Road Slope (%)	1.3	
	X Walk 1 Direction	To NW		Road X Slope (%)	0.4

0001010 001411011	
Possible Solutions:	Compli
Remove & Replace Entire Ramp.	N/A
·	Yes
	Yes
	No
	N/A
	N/A
Surveyor Notes:	N/A
N/A	N/A
	N/A
	N/A
	N/A
PROW/ADA:	N/A
R304.5.3	N/A
	N/A
	N/A
	N/A
