Access Compliance Report Public Rights-of-Way (Curb Ramps)

Intersection ID: 27041Main Street:ENDHAVEN_LNCross Street:ORCHID_HILL_LNLocation:NEADA ID: 341A2773B86ARamp Type:PerpInitial Pass/Fail:FailOverall Compliance:NoSeverity Score:33.75

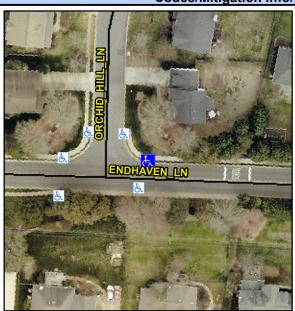
Field Measurements/Component Compliance							
Compliance Description Data		Data	Comp	liance Description	Data		
N/A	Ramp Length (in)	27.0	Yes	Ramp Slope (%)	7.4		
No	Ramp Width (in)	47.0	No	Ramp XSlope (%)	7.4		
N/A	Flare Type LT	N/A	N/A	Flare Type RT	N/A		
N/A	Flare Slope LT (%)	N/A	N/A	Flare Slope RT (%)	N/A		
N/A	Flare Traversable LT?	N/A	N/A	Flare Traversable RT?	N/A		
N/A	Landing Length (in)	N/A	N/A	DWS Provided?	N/A		
N/A	Landing Width (in)	N/A	N/A	DWS Contrast?	N/A		
N/A	Landing Slope (%)	N/A	N/A	DWS Length (in)	N/A		
N/A	Landing X Slope (%)	N/A	N/A	DWS Full Width?	N/A		
N/A	Landing Curb? (Y/N)	N/A	N/A	DWS Offset (in)	N/A		
N/A	Shared Landing?	N/A					
N/A	Gutter Ponding?	N/A	N/A	Gutter Slope (%)	N/A		
N/A	Gutter Lip Ht (in)	N/A	N/A	Gutter X Slope (%)	N/A		
N/A	Painted X Walk1?	No	N/A	Painted X Walk2?	N/A		
	X Walk 1 Direction	To SW		X Walk 2 Direction	N/A		
N/A	X Walk 1 Width (in)	N/A	N/A	X Walk 2 Width (in)	N/A

X Walk 1 Slope (%)	1.2		X Walk 2 Slope (%)	N/A		
	X Walk 1 X Slope (%)	5.8		X Walk 2 X Slope (%)	N/A		
N/A	Ramp inside XWalk1?	N/A	N/A	Ramp inside XWalk2?	N/A		
	Road Slope (%)	N/A	N/A	Clear Space?	N/A		
	Road X Slope (%)	N/A	N/A	Clear Space to XWalk (in)	N/A		
N/A	Any Obstructions?	N/A	N/A	Storm Grate/Utility Hazard?	N/A		
	Obstruction Type			Storm Grate/Utility Type			
		N/A			N/A		
			Yes	Surface Condition? (G/P)	Good

Possible Solutions:						
Remove & Replace Entire Ramp.						
Surveyor Notes:						
N/A						
PROM/ARA						
PROW/ADA:						
Not Found, R304.5.1, R304.5.3
