Access Compliance Report

Public Rights-of-Way

(Curb Ramps)

| Intersection ID: 10622 | Main Street: MULBERRY_CHURCH_RD | Cross Street: QUEEN_CITY_DR | Location: NE |

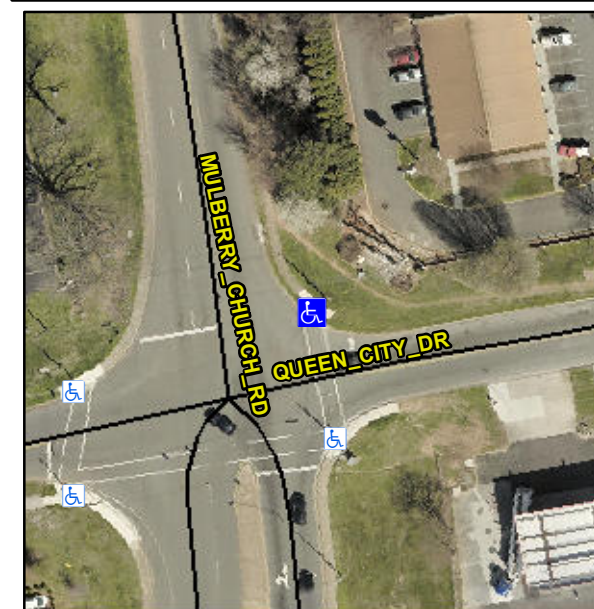
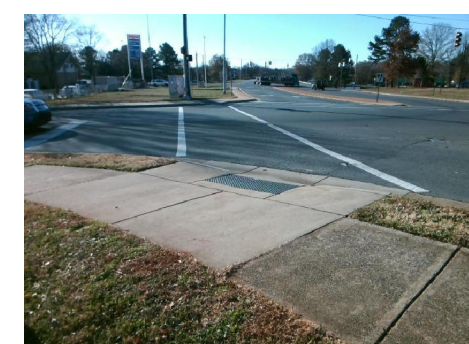
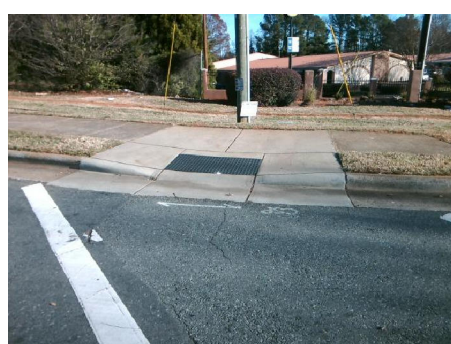
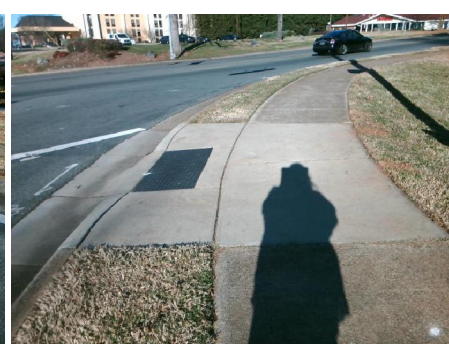
| ADA ID: 34B1B7636607 | Ramp Type: Perp | Initial Pass/Fail: Fail | Overall Compliance: No |
| Severity Score: 13.75 | | | |

Not Found, R304.2.2, R304.5.3

| Compliance | Description | Data | Compliance | Description | Data |
|---|---|---|---|---|---|
| N/A | Ramp Length (in) | 35.5 | No | Ramp Slope (%) | 9.3 |
| Yes | Ramp Width (in) | 48.0 | No | Ramp XSlope (%) | 4.7 |

Remove & Replace Entire Ramp.
