# Access Compliance Report

## Public Rights-of-Way

### (Curb Ramps)

| Intersection ID: 4147 | Main Street: DAVIS_LAKE_PY | Cross Street: SAGEWOOD_PL | Location: NE |

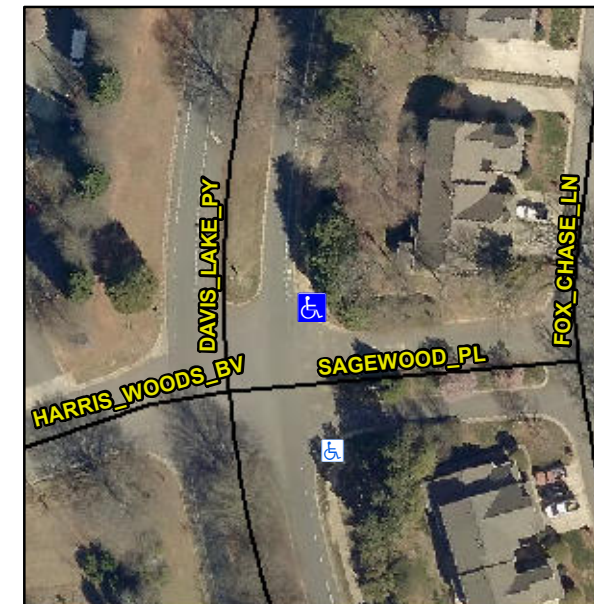
| ADA ID: 34F876363544 | Ramp Type: Perp | Initial Pass/Fail: Fail | Overall Compliance: No |

**R304.2.2, R304.5.3**

| Compliance | Description | Data | Compliance | Description | Data |
|---|---|---|---|---|---|
| N/A | Ramp Length (in) | 48.0 | No | Ramp Slope (%) | 20.0 |
| Yes | Ramp Width (in) | 51.0 | No | Ramp XSlope (%) | 10.0 |

**Remove & Replace Entire Ramp.**
