Access Compliance Report

Public Rights-of-Way

(Curb Ramps)

Intersection ID: 50607	Main Street: DENBUR_DR	Cross Street: STREAM_ORCHID_LN	Location: SE
ADA ID: 353D64F16794	Ramp Type: Perp	Initial Pass/Fail: Fail	Overall Compliance: No
Severity Score: 10			
Codes/Mitigation Info/Possible Solution		Field Measurements/Component Compliance

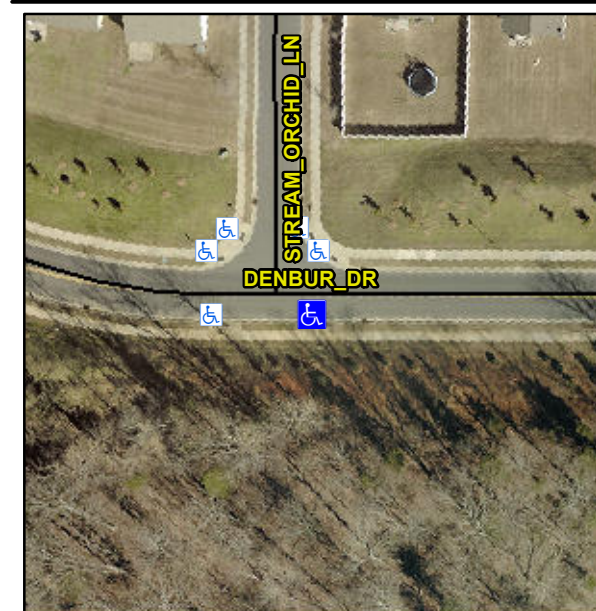
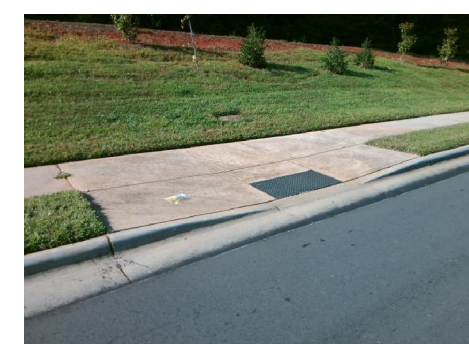
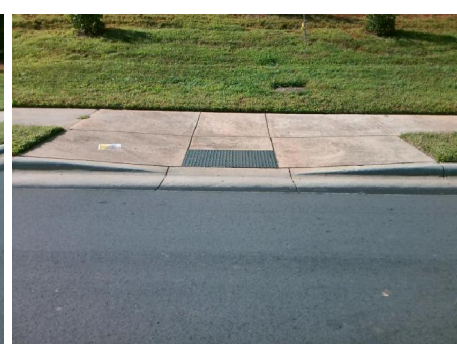
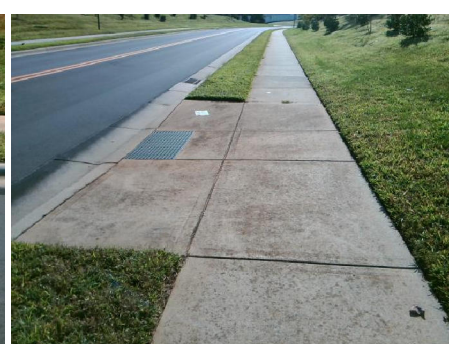
Not Found, R304.5.1

Compliance	Description	Data	Compliance	Description	Data
N/A	Ramp Length (in)	49.0	Yes	Ramp Slope (%)	7.3
No	Ramp Width (in)	47.5	Yes	Ramp XSlope (%)	3.3
N/A	Flare Type LT	N/A	N/A	Flare Type RT	N/A
N/A	Flare Slope LT (%)	N/A	N/A	Flare Slope RT (%)	N/A
N/A	Flare Traversable LT?	N/A	N/A	Flare Traversable RT?	N/A
N/A	Landing Length (in)	N/A	N/A	DWS Provided?	N/A
N/A	Landing Width (in)	N/A	N/A	DWS Contrast?	N/A
N/A	Landing Slope (%)	N/A	N/A	DWS Length (in)	N/A
N/A	Landing X Slope (%)	N/A	N/A	DWS Full Width?	N/A
N/A	Landing Curb? (Y/N)	N/A	N/A	DWS Offset (in)	N/A
N/A	Shared Landing?	N/A			
N/A	Gutter Ponding?	N/A	N/A	Gutter Slope (%)	N/A
N/A	Gutter Lip Ht (in)	N/A	N/A	Gutter X Slope (%)	N/A
N/A	Painted X Walk1?	No	N/A	Painted X Walk2?	N/A
	X Walk 1 Direction	To N		X Walk 2 Direction	N/A
N/A	X Walk 1 Width (in)	N/A	N/A	X Walk 2 Width (in)	N/A
	X Walk 1 Slope (%)	2.1		X Walk 2 Slope (%)	N/A
	X Walk 1 X Slope (%)	3.5		X Walk 2 X Slope (%)	N/A

Remove & Replace Entire Ramp.
