Access Compliance Report

Public Rights-of-Way

(Curb Ramps)

Intersection ID: 13333	Main Street: BURGIN_ST	Cross Street: MEDFORD_DR	Location: SE
ADA ID: 3547214BFA5E	Ramp Type: Perp	Initial Pass/Fail: Fail	Overall Compliance: No
Codes/Mitigation Info/Possible Solution		Field Measurements/Component Compliance	
Severity Score: 18.75

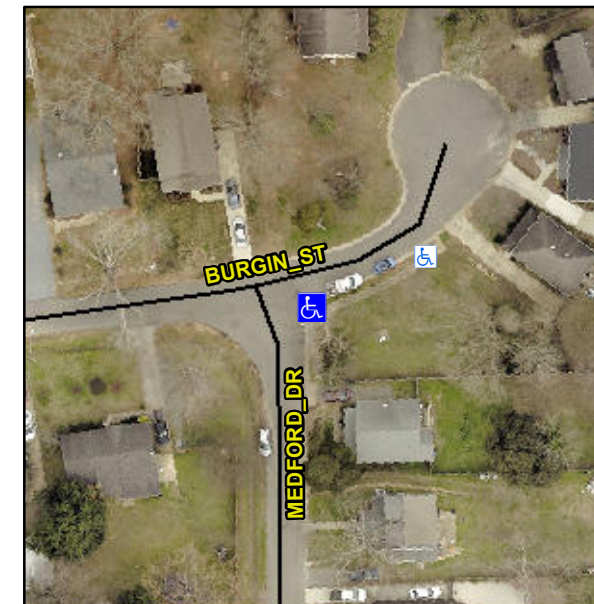
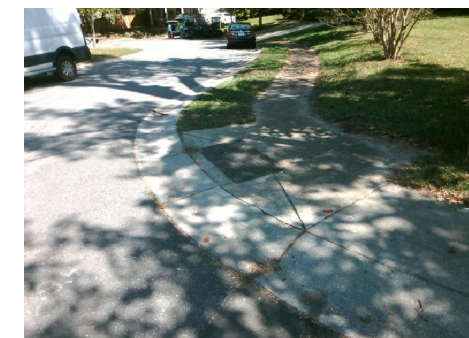
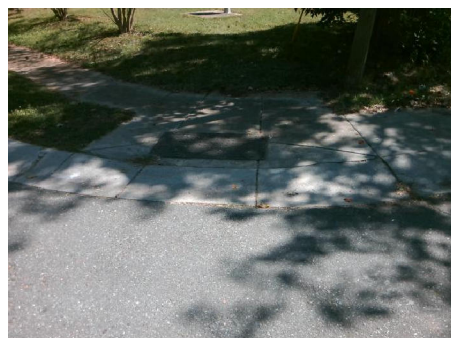
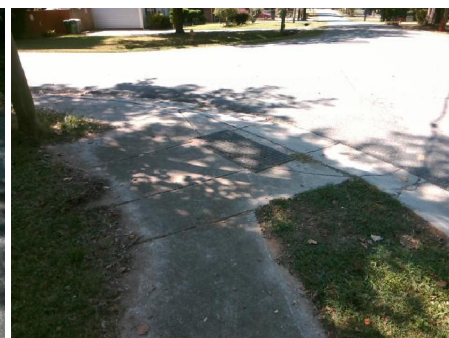
Not Found, R304.5.1, R304.5.3

Compliance	Description	Data	Compliance	Description	Data
N/A	Ramp Length (in)	92.0	Yes	Ramp Slope (%)	5.2
No	Ramp Width (in)	32.0	No	Ramp XSlope (%)	3.5
N/A	Flare Type LT	N/A	N/A	Flare Type RT	N/A
N/A	Flare Slope LT (%)	N/A	N/A	Flare Slope RT (%)	N/A
N/A	Flare Traversable LT?	N/A	N/A	Flare Traversable RT?	N/A
N/A	Landing Length (in)	N/A	N/A	DWS Provided?	N/A
N/A	Landing Width (in)	N/A	N/A	DWS Contrast?	N/A
N/A	Landing Slope (%)	N/A	N/A	DWS Length (in)	N/A
N/A	Landing X Slope (%)	N/A	N/A	DWS Full Width?	N/A
N/A	Landing Curb? (Y/N)	N/A	N/A	DWS Offset (in)	N/A
N/A	Shared Landing?	N/A			
N/A	Gutter Ponding?	N/A	N/A	Gutter Slope (%)	N/A
N/A	Gutter Lip Ht (in)	N/A	N/A	Gutter X Slope (%)	N/A
N/A	Painted X Walk1?	No	N/A	Painted X Walk2?	N/A
	X Walk 1 Direction	To W		X Walk 2 Direction	N/A
N/A	X Walk 1 Width (in)	N/A	N/A	X Walk 2 Width (in)	N/A
	X Walk 1 Slope (%)	3.0		X Walk 2 Slope (%)	N/A
	X Walk 1 X Slope (%)	1.8		X Walk 2 X Slope (%)	N/A

N/A	Ramp inside XWalk1?	N/A	N/A	Ramp inside XWalk2?	N/A
	Road Slope (%)	1.8	N/A	Clear Space?	N/A
	Road X Slope (%)	3.0	N/A	Clear Space to XWalk (in)	N/A
N/A	Any Obstructions?	N/A	N/A	Storm Grate/Utility Hazard?	N/A
	Obstruction Type			Storm Grate/Utility Type	
		N/A			N/A
			Yes	Surface Condition? (G/P)	Good

Possible Solutions:

Remove & Replace Entire Ramp.
