# Access Compliance Report

## Public Rights-of-Way

### (Curb Ramps)

Intersection ID: 15231	Main Street: ALBEMARLE_RD	Cross Street: THORN GROVE_LN	Location: SW
ADA ID: 354C0A1E16A0	Ramp Type: Combination1	Initial Pass/Fail: Fail	Overall Compliance: No
			Severity Score: 13.75

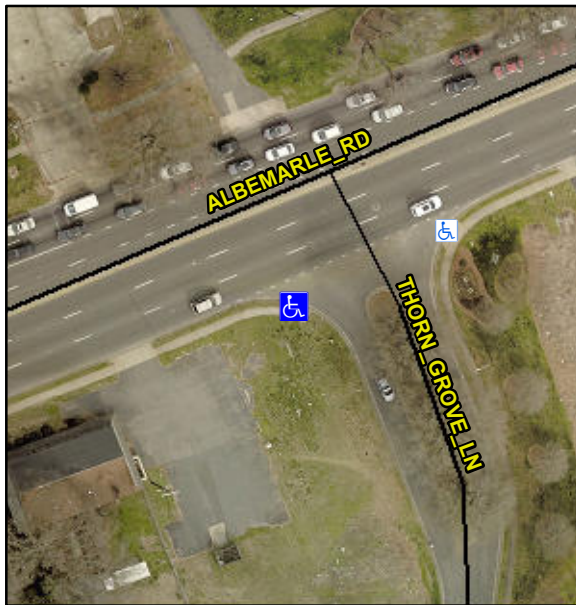
**LT RP < 5%**

**Not Found, R304.5.3, R304.3.2**

Compliance	Description	Data	Compliance	Description	Data
N/A	Ramp Length LT (in)	56.5	N/A	Ramp Length RT (in)	56.5
Yes	Ramp Width LT (in)	59.0	Yes	Ramp Width RT (in)	59.5
Yes	Ramp Slope LT (%)	1.8	No	Ramp Slope RT (%)	8.8
Yes	Ramp XSlope LT (%)	1.3	No	Ramp XSlope RT (%)	2.5
N/A	Ramp Length (in)	31.0	Yes	Ramp Slope (%)	7.1
Yes	Ramp Width (in)	48.0	No	Ramp XSlope (%)	4.3
N/A	Flare Type LT	N/A	N/A	Flare Type RT	N/A
N/A	Flare Slope LT (%)	N/A	N/A	Flare Slope RT (%)	N/A
N/A	Flare Traversable LT?	N/A	N/A	Flare Traversable RT?	N/A
N/A	Landing Length (in)	N/A	N/A	DWS Provided?	N/A
N/A	Landing Width (in)	N/A	N/A	DWS Contrast?	N/A
N/A	Landing Slope (%)	N/A	N/A	DWS Length (in)	N/A
N/A	Landing X Slope (%)	N/A	N/A	DWS Full Width?	N/A
N/A	Landing Curb? (Y/N)	N/A	N/A	DWS Offset (in)	N/A
N/A	Shared Landing?	N/A			
N/A	Gutter Ponding?	N/A	N/A	Gutter Slope (%)	N/A
N/A	Gutter Lip Ht (in)	N/A	N/A	Gutter X Slope (%)	N/A
N/A	Painted X Walk1?	No	N/A	Painted X Walk2?	N/A

**Remove & Replace Entire Ramp.**
