# Access Compliance Report

## Public Rights-of-Way

### (Curb Ramps)

| Intersection ID: 52457 | Main Street: ORCHARD_LAKE_DR | Cross Street: LUCY_JANE_LN | Location: S |

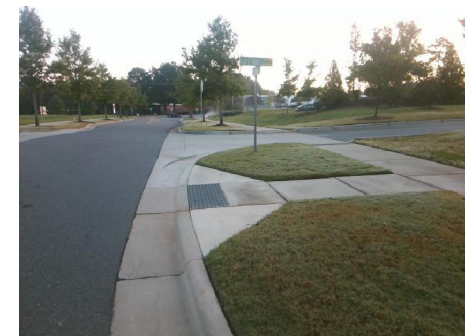
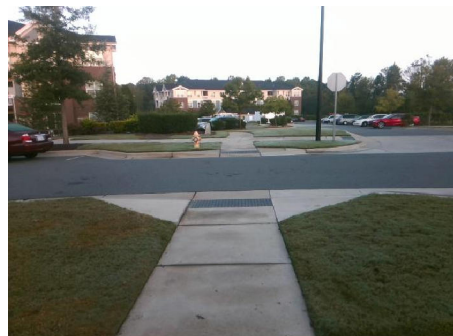
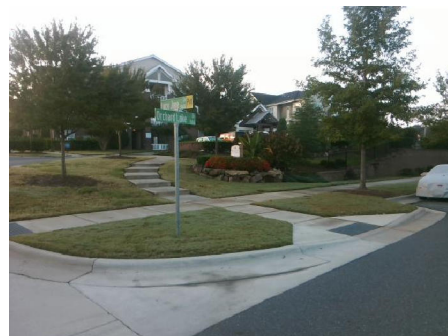
**Not Found, R304.2.2-Perp, R304.3.2-Para**

| Compliance | Description | Data | Compliance | Description | Data |
|---|---|---|---|---|---|
| No | Landing Slope (%) | 2.7 | Yes | DWS Length (in) | 24.0 |
| | | | No | Curb Slope (%) | 5.1 |

**Remove & Replace Curb Ramp With Two New Directional Ramps or Equivalent.**
