## Access Compliance Report Public Rights-of-Way (Curb Ramps)

Intersection ID: 4923 Main Street: HEDGECREST\_PL Cross Street: MAYSPRING\_PL Location: W

ADA ID: 361D64559062 Ramp Type: Perp Initial Pass/Fail: Fail Overall Compliance: No Severity Score: 26.25

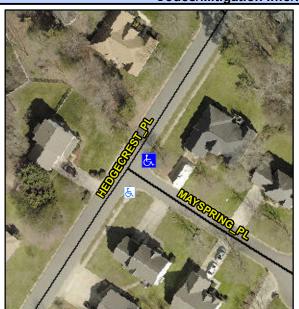
Not Found, R304.2.2, R304.5.3

Fleid Measurements/Component Compliance					
Compliance Description			Compliance Description		Data
N/A	Ramp Length (in)	48.0	No	Ramp Slope (%)	20.0
Yes	Ramp Width (in)	48.0	No	Ramp XSlope (%)	3.0
N/A	Flare Type LT	N/A	N/A	Flare Type RT	N/A
N/A	Flare Slope LT (%)	N/A	N/A	Flare Slope RT (%)	N/A
N/A	Flare Traversable LT?	N/A	N/A	Flare Traversable RT?	N/A
N/A	Landing Length (in)	N/A	N/A	DWS Provided?	N/A
N/A	Landing Width (in)	N/A	N/A	DWS Contrast?	N/A
N/A	Landing Slope (%)	N/A	N/A	DWS Length (in)	N/A
N/A	Landing X Slope (%)	N/A	N/A	DWS Full Width?	N/A
N/A	Landing Curb? (Y/N)	N/A	N/A	DWS Offset (in)	N/A
N/A	Shared Landing?	N/A			
N/A	Gutter Ponding?	N/A	N/A	Gutter Slope (%)	N/A
N/A	Gutter Lip Ht (in)	N/A	N/A	Gutter X Slope (%)	N/A
N/A	Painted X Walk1?	No	N/A	Painted X Walk2?	N/A
	X Walk 1 Direction	To SE		X Walk 2 Direction	N/A
N/A	X Walk 1 Width (in)	N/A	N/A	X Walk 2 Width (in)	N/A
	X Walk 1 Slope (%)	5.2		X Walk 2 Slope (%)	N/A

Remove & Replace Entire Ramp.
