# Access Compliance Report

## Public Rights-of-Way

### (Curb Ramps)

Intersection ID: 10021134	Main Street: BEVINGTON_PL	Cross Street: N/A	Location: S
ADA ID: 3687FACE1EAA	Ramp Type: Perp	Initial Pass/Fail: Fail	Overall Compliance: No
			Severity Score: 13.75

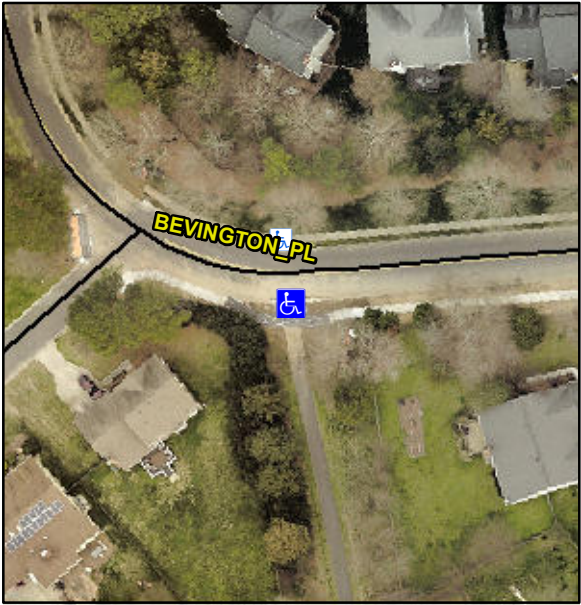
Possible Solutions:		<b>Compliance</b>	<b>Description</b>	<b>Data</b>
	Remove & Replace Entire Ramp.		N/A	Ramp Length (in)	24.0
			Yes	Ramp Width (in)	48.0
			N/A	Flare Type LT	N/A
			N/A	Flare Slope LT (%)	N/A
			N/A	Flare Traversable LT?	N/A
			N/A	Landing Length (in)	N/A
			N/A	Landing Width (in)	N/A
			N/A	Landing Slope (%)	N/A
			N/A	Landing X Slope (%)	N/A
			N/A	Landing Curb? (Y/N)	N/A
			N/A	Shared Landing?	N/A
			N/A	Gutter Ponding?	N/A
			N/A	Gutter Lip Ht (in)	N/A
			N/A	Painted X Walk1?	No
				X Walk 1 Direction	To N
			N/A	X Walk 1 Width (in)	N/A
				X Walk 1 Slope (%)	4.7
				X Walk 1 X Slope (%)	3.7
			N/A	Ramp inside XWalk1?	N/A
<p>Surveyor Notes:</p> <p>N/A</p> <p>PROW/ADA:</p> <p>R304.2.2, R304.5.3</p>			N/A	Ramp Slope (%)	9.1
			No	Ramp XSlope (%)	4.8
			N/A	Flare Type RT	N/A
			N/A	Flare Slope RT (%)	N/A
			N/A	Flare Traversable RT?	N/A
