Access Compliance Report

Public Rights-of-Way

(Curb Ramps)

Intersection ID: 18157	Main Street: GILMORE_DR	Cross Street: MURRAYHILL_RD	Location: SE
ADA ID: 368CAC8BC506	Ramp Type: Perp	Initial Pass/Fail: Fail	Overall Compliance: No
		Severity Score: 12.5

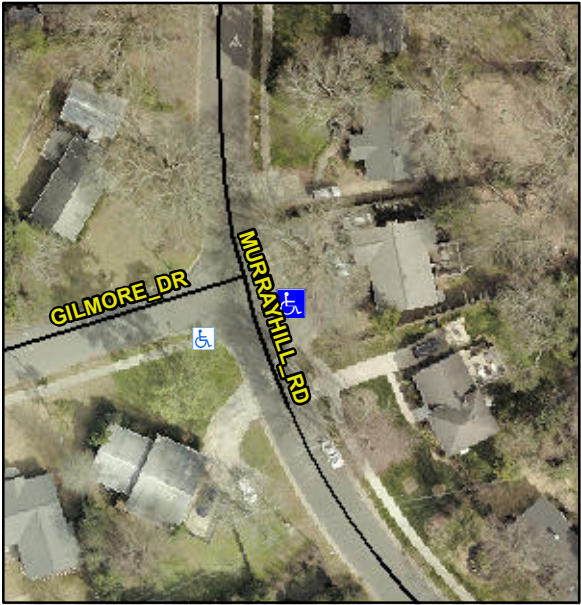
Possible Solutions:		Compliance	Description	Data
	Remove & Replace Entire Ramp.		Yes	Ramp Length (in)	60.0
			N/A	Ramp Width (in)	48.0
			N/A	Flare Type LT	N/A
			N/A	Flare Slope LT (%)	N/A
			N/A	Flare Traversable LT?	N/A
			N/A	Landing Length (in)	N/A
			N/A	Landing Width (in)	N/A
			N/A	Landing Slope (%)	N/A
			N/A	Landing X Slope (%)	N/A
<p>Surveyor Notes:</p> <p>N/A</p> <p>PROW/ADA:</p> <p>Not Found, R304.5.3</p>			N/A	Flare Type RT	N/A
			N/A	Flare Slope RT (%)	N/A
			N/A	Flare Traversable RT?	N/A
			N/A	DWS Provided?	N/A
			N/A	DWS Contrast?	N/A
			N/A	DWS Length (in)	N/A
			N/A	DWS Full Width?	N/A
			N/A	DWS Offset (in)	N/A
			N/A	Shared Landing?	N/A
			N/A	Gutter Ponding?	N/A
			N/A	Gutter Lip Ht (in)	N/A
			N/A	Painted X Walk1?	No
				X Walk 1 Direction	To W
			N/A	X Walk 1 Width (in)	N/A
				X Walk 1 Slope (%)	6.0
				X Walk 1 X Slope (%)	7.0

N/A	Ramp inside XWalk1?	N/A
			N/A	Road Slope (%)	N/A
			N/A	Road X Slope (%)	N/A
			N/A	Any Obstructions?	N/A
Total Cost:		\$ 1850.00		Obstruction Type	
			N/A		
			N/A	Clear Space?	N/A
			N/A	Clear Space to XWalk (in)	N/A
			N/A	Storm Grate/Utility Hazard?	N/A
				Storm Grate/Utility Type	
			N/A		N/A
			Yes	Surface Condition? (G/P)	Good
