# Access Compliance Report

## Public Rights-of-Way

### (Curb Ramps)

Intersection ID: 7528	Main Street: LEMS福德_WY	Cross Street: SILCHESTER_LN	Location:	E
ADA ID: 36C33C845073	Ramp Type: Directional1	Initial Pass/Fail: Fail	Overall Compliance: No	Severity Score: 12.5

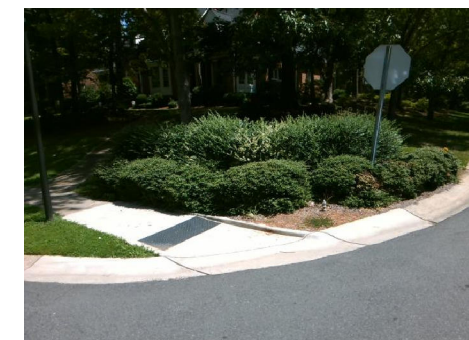
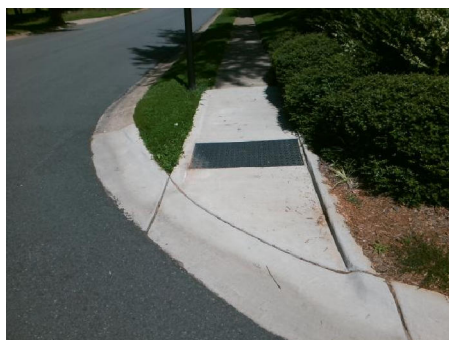
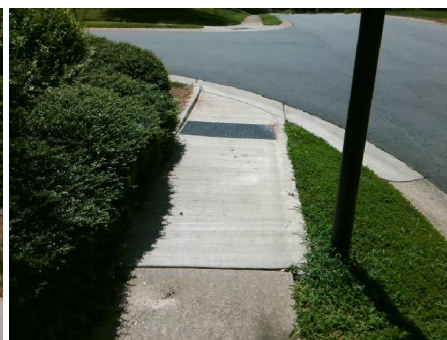
Compliance	Description	Data	Compliance	Description	Data
N/A	Ramp Length (in)	114.5	N/A	Grade Break?	N/A
Yes	Ramp Width (in)	48.0	N/A	Grade Break Slope (%)	0.0
Yes	Ramp Slope (%)	7.1	N/A	Grade Break XSlope (%)	0.0
No	Ramp XSlope (%)	6.7			
N/A	Flare Type LT	N/A	N/A	Flare Type RT	N/A
N/A	Flare Slope LT (%)	N/A	N/A	Flare Slope RT (%)	0.0
N/A	Flare Traversable LT?	N/A	N/A	Flare Traversable RT?	N/A
N/A	Landing Length (in)	0.0	N/A	DWS Provided?	N/A
N/A	Landing Width (in)	0.0	N/A	DWS Contrast?	N/A
N/A	Landing Slope (%)	0.0	N/A	DWS Length (in)	N/A
N/A	Landing X Slope (%)	0.0	N/A	DWS Full Width?	N/A
N/A	Landing Curb? (Y/N)	N/A	N/A	DWS Offset LT (in)	N/A
N/A	Shared Landing?	N/A	N/A	DWS Offset RT (in)	N/A
N/A	Gutter Ponding?	0.0	N/A	Gutter Slope (%)	N/A
N/A	Gutter Lip Ht (in)	0.0	N/A	Gutter X Slope (%)	N/A
N/A	Painted X Walk1?	No		Road Slope (%)	2.5
	X Walk 1 Direction	To SW		Road X Slope (%)	3.3
	X Walk 1 Width (in)	N/A		Clear Space?	N/A

X Walk 1 Slope (%)	2.5	N/A	Clear Space to XWalk (in)	N/A
	X Walk 1 X Slope (%)	3.3	N/A	Storm Grate/Utility Hazard?	N/A
N/A	Ramp inside XWalk1?	N/A		Storm Grate/Utility Type	
N/A	Any Obstructions?	N/A			N/A
	Obstruction Type		Yes	Surface Condition? (G/P)	Good
			N/A	Curb Slope (%)	9.0

**Remove & Replace Entire Ramp.**
