## **Access Compliance Report Public Rights-of-Way** (Curb Ramps)

Intersection ID: N/A Main Street: BALLANTYNE VILLAGE DR Cross Street: N/A Location: NE ADA ID: 372CEDAB8BE4 Ramp Type: PerpDiag Initial Pass/Fail: Fail **Overall Compliance: No Severity Score:** 22.5

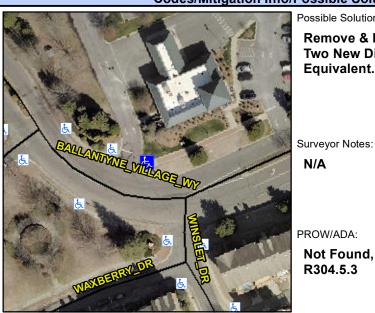
Not Found, R304.5.1, R304.2.2, R304.5.3

| Compliance Description | | Data | Compliance | | Description | Data |
|---|---|---|---|---|---|---|
| N/A | Ramp Length (in) | 80.0 | No | Ramp | Slope (%) | 10.6 |
| No | Ramp Width (in) | 38.0 | No | Ramp | XSlope (%) | 2.1 |

Possible Solutions: Remove & Replace Curb Ramp With Two New Directional Ramps or Equivalent.
