Access Compliance Report Public Rights-of-Way (Curb Ramps)

Intersection ID: 23178Main Street:OBERWOOD_DRCross Street:PROVIDENCE_RDLocation:NEADA ID: 37579F08AD11Ramp Type:PerpDiagInitial Pass/Fail:FailOverall Compliance:NoSeverity Score:22.5

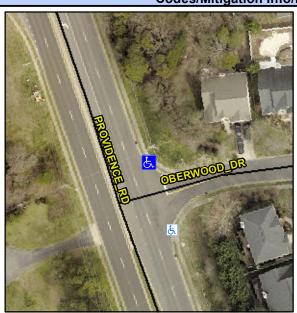
R304.5.1, R304.2.2, R304.5.3

Compliance Description		Data	Comp	liance Description	Data
N/A Ramp Length (in)		72.0	No Ramp Slope (%)		10.0
No	Ramp Width (in)	45.0	No	Ramp XSlope (%)	3.6
N/A	. ,	N/A	N/A	,	N/A
	Flare Type LT		l	Flare Type RT	
N/A	Flare Slope LT (%)	N/A	N/A	Flare Slope RT (%)	N/A
N/A	Flare Traversable LT?	N/A	N/A	Flare Traversable RT?	N/A
N/A	Landing Length (in)	N/A	N/A	DWS Provided?	N/A
N/A	Landing Width (in)	N/A	N/A	DWS Contrast?	N/A
N/A	Landing Slope (%)	N/A	N/A	DWS Length (in)	N/A
N/A	Landing X Slope (%)	N/A	N/A	DWS Full Width?	N/A
N/A	Landing Curb? (Y/N)	N/A	N/A	DWS Offset (in)	N/A
N/A	Shared Landing?	N/A			
N/A	Gutter Ponding?	N/A	N/A	Gutter Slope (%)	N/A
N/A	Gutter Lip Ht (in)	N/A	N/A	Gutter X Slope (%)	N/A
N/A	Painted X Walk1?	No	N/A	Painted X Walk2?	No
	X Walk 1 Direction	To W		X Walk 2 Direction	To SE
N/A	X Walk 1 Width (in)	N/A	N/A	X Walk 2 Width (in)	N/A
	X Walk 1 Slope (%)	5.5		X Walk 2 Slope (%)	2.7
	X Walk 1 X Slope (%)	0.2		X Walk 2 X Slope (%)	2.3

Remove & Replace Curb Ramp With Two New Directional Ramps or Equivalent.
