## **Access Compliance Report Public Rights-of-Way** (Curb Ramps)

Intersection ID: 2857 Main Street: BEAUVISTA DR **Cross Street: BEECH COVE LN** Location: NW ADA ID: 3763B957DF79 Ramp Type: PerpDiag Initial Pass/Fail: Fail **Overall Compliance: No** Severity Score: 33.75

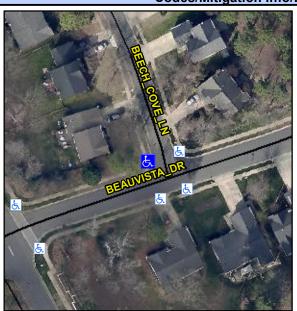
Field Measurements/Component Compliance					
Compliance Description		Data	Comp	liance Description	Data
N/A	Ramp Length (in)	43.0	No	Ramp Slope (%)	10.2
No	Ramp Width (in)	37.5	No	Ramp XSlope (%)	6.8
N/A	Flare Type LT	N/A	N/A	Flare Type RT	N/A
N/A	Flare Slope LT (%)	N/A	N/A	Flare Slope RT (%)	N/A
N/A	Flare Traversable LT?	N/A	N/A	Flare Traversable RT?	N/A
N/A	Landing Length (in)	N/A	N/A	DWS Provided?	N/A
N/A	Landing Width (in)	N/A	N/A	DWS Contrast?	N/A
N/A	Landing Slope (%)	N/A	N/A	DWS Length (in)	N/A
N/A	Landing X Slope (%)	N/A	N/A	DWS Full Width?	N/A
N/A	Landing Curb? (Y/N)	N/A	N/A	DWS Offset (in)	N/A
N/A	Shared Landing?	N/A			
N/A	Gutter Ponding?	N/A	N/A	Gutter Slope (%)	N/A
N/A	Gutter Lip Ht (in)	N/A	N/A	Gutter X Slope (%)	N/A
N/A	Painted X Walk1?	No	N/A	Painted X Walk2?	No
	X Walk 1 Direction	To S		X Walk 2 Direction	ТоЕ
N/A	X Walk 1 Width (in)	N/A	N/A	X Walk 2 Width (in)	N/A
	X Walk 1 Slope (%)	6.1		X Walk 2 Slope (%)	6.4

X Walk 1 X Slope (%)	7.0		X Walk 2 X Slope (%)	0.9
N/A	Ramp inside XWalk1?	N/A	N/A	Ramp inside XWalk2?	N/A
	Road Slope (%)	4.0	N/A	Clear Space?	N/A
	Road X Slope (%)	8.7	N/A	Clear Space to XWalk (in)	N/A
N/A	Any Obstructions?	N/A	N/A	Storm Grate/Utility Hazard?	N/A
	Obstruction Type			Storm Grate/Utility Type	
		N/A			N/A
			Yes	Surface Condition? (G/P)	Good

**BEAUVISTA DR** None **BEECH COVE LN** StopSign Possible Solutions: Remove & Replace Curb Ramp With Two New Directional Ramps or Equivalent. Surveyor Notes: N/A PROW/ADA: Not Found, R304.5.1, R304.2.2, R304.5.3
