Access Compliance Report

Public Rights-of-Way

(Curb Ramps)

Intersection ID: 7034	Main Street: GRAHAM_MEADOW_DR	Cross Street: PESCA_LN	Location: W
ADA ID: 37D1BB6F7328	Ramp Type: Directional1	Initial Pass/Fail: Pass	Overall Compliance: No
Severity Score: 0			
Codes/Mitigation Info/Possible Solution		Field Measurements/Component Compliance

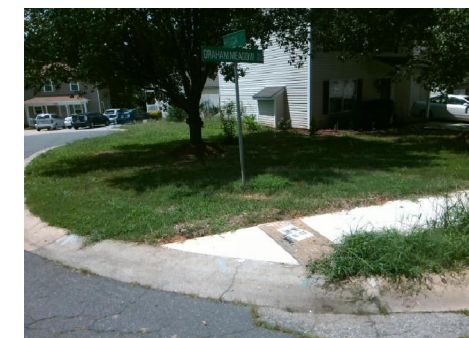
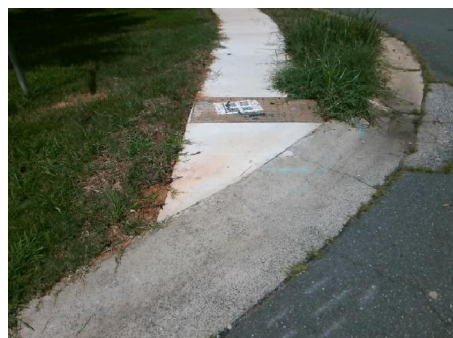
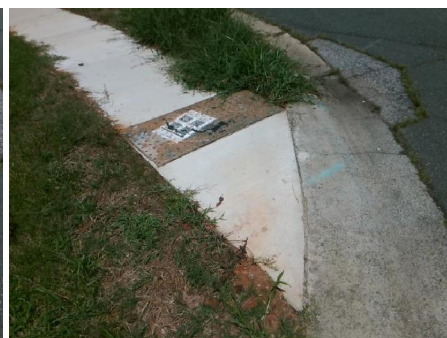
Not Found, R304.5.3

Compliance	Description	Data	Compliance	Description	Data
N/A	Ramp Length (in)	24.0	Yes	Grade Break?	Yes
Yes	Ramp Width (in)	48.0	Yes	Grade Break Slope (%)	0.2
Yes	Ramp Slope (%)	0.5	Yes	Grade Break XSlope (%)	0.1
Yes	Ramp XSlope (%)	0.5			
N/A	Flare Type LT	N/A	N/A	Flare Type RT	N/A
N/A	Flare Slope LT (%)	N/A	N/A	Flare Slope RT (%)	N/A
N/A	Flare Traversable LT?	N/A	N/A	Flare Traversable RT?	N/A
Yes	Landing Length (in)	62.5	Yes	DWS Provided?	Yes
Yes	Landing Width (in)	48.0	Yes	DWS Contrast?	Yes
Yes	Landing Slope (%)	0.1	Yes	DWS Length (in)	24.0
No	Landing X Slope (%)	2.7	Yes	DWS Full Width?	Yes
N/A	Landing Curb? (Y/N)	No	Yes	DWS Offset LT (in)	52.0
N/A	Shared Landing?	No	Yes	DWS Offset RT (in)	2.0
Yes	Gutter Ponding?	No	Yes	Gutter Slope (%)	1.6
Yes	Gutter Lip Ht (in)	0.0	Yes	Gutter X Slope (%)	0.9
N/A	Painted X Walk1?	No		Road Slope (%)	5.7
	X Walk 1 Direction	To SE		Road X Slope (%)	3.4
	X Walk 1 Width (in)	N/A		Clear Space?	Yes

X Walk 1 Slope (%)	5.7	N/A	Clear Space to XWalk (in)	N/A
	X Walk 1 X Slope (%)	3.4	Yes	Storm Grate/Utility Hazard?	No
N/A	Ramp inside XWalk1?	N/A		Storm Grate/Utility Type	
Yes	Any Obstructions?	No			N/A
	Obstruction Type		Yes	Surface Condition? (G/P)	Good
			N/A	Curb Slope (%)	17.2

Remove & Replace Entire Ramp.

Total Cost: \$ 1600.00
