Access Compliance Report

Public Rights-of-Way

(Curb Ramps)

Intersection ID: 49791	Main Street: BAHIA_LN	Cross Street: BARLEY_LN	Location: W
ADA ID: 37FA69C737C6	Ramp Type: Perp	Initial Pass/Fail: Fail	Overall Compliance: No
Severity Score: 12.5			
Codes/Mitigation Info/Possible Solution		Field Measurements/Component Compliance

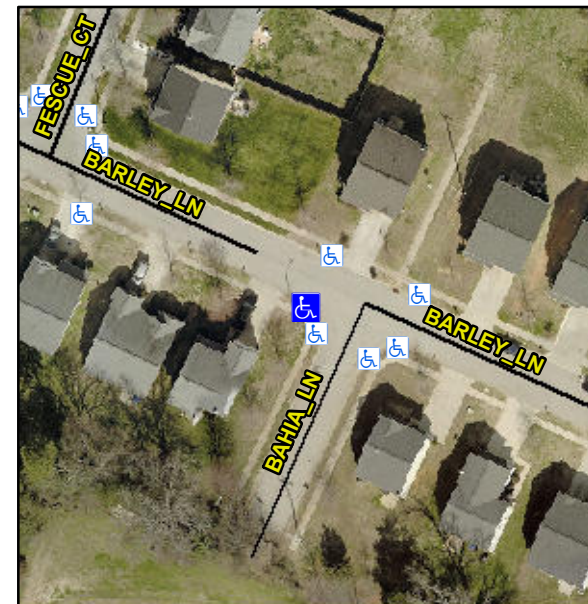
Not Found, R304.5.3

Compliance	Description	Data	Compliance	Description	Data
N/A	Ramp Length (in)	48.0	Yes	Ramp Slope (%)	6.7
Yes	Ramp Width (in)	48.0	No	Ramp XSlope (%)	6.7
N/A	Flare Type LT	N/A	N/A	Flare Type RT	N/A
N/A	Flare Slope LT (%)	N/A	N/A	Flare Slope RT (%)	N/A
N/A	Flare Traversable LT?	N/A	N/A	Flare Traversable RT?	N/A
N/A	Landing Length (in)	N/A	N/A	DWS Provided?	N/A
N/A	Landing Width (in)	N/A	N/A	DWS Contrast?	N/A
N/A	Landing Slope (%)	N/A	N/A	DWS Length (in)	N/A
N/A	Landing X Slope (%)	N/A	N/A	DWS Full Width?	N/A
N/A	Landing Curb? (Y/N)	N/A	N/A	DWS Offset (in)	N/A
N/A	Shared Landing?	N/A			
N/A	Gutter Ponding?	N/A	N/A	Gutter Slope (%)	N/A
N/A	Gutter Lip Ht (in)	N/A	N/A	Gutter X Slope (%)	N/A
N/A	Painted X Walk1?	No	N/A	Painted X Walk2?	N/A
	X Walk 1 Direction	To NE		X Walk 2 Direction	N/A
N/A	X Walk 1 Width (in)	N/A	N/A	X Walk 2 Width (in)	N/A
	X Walk 1 Slope (%)	3.9		X Walk 2 Slope (%)	N/A
	X Walk 1 X Slope (%)	4.2		X Walk 2 X Slope (%)	N/A

Remove & Replace Entire Ramp.

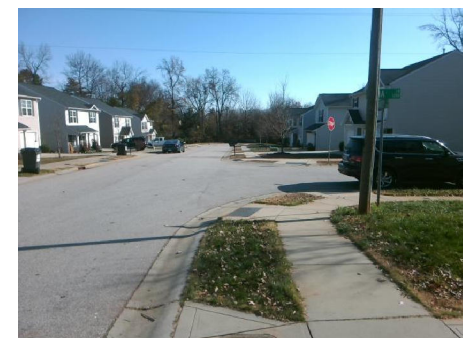
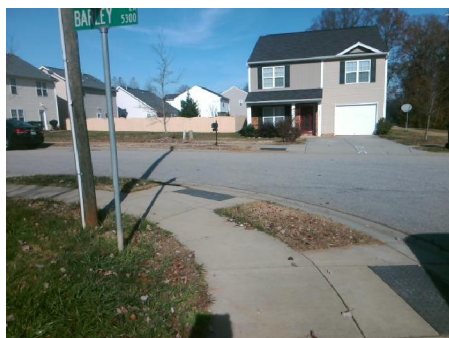
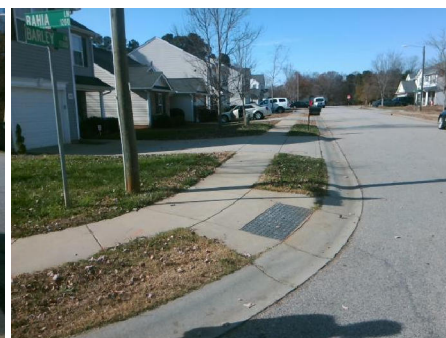
N/A	Ramp inside XWalk1?	N/A	N/A	Ramp inside XWalk2?	N/A
	Road Slope (%)	N/A	N/A	Clear Space?	N/A
	Road X Slope (%)	N/A	N/A	Clear Space to XWalk (in)	N/A
N/A	Any Obstructions?	N/A	N/A	Storm Grate/Utility Hazard?	N/A
	Obstruction Type			Storm Grate/Utility Type	
		N/A			N/A
		Yes		Surface Condition? (G/P)	Good
